G R E E L E Y A R M O R Y
6 1 4 8 t h A v e n u e
G r e e l e y , C o l o r a d o 8 0 6 3 1

HISTORIC
STRUCTURE
ASSESSMENT
2009-HA-022

1 0 . 1 . 2 0 0 9

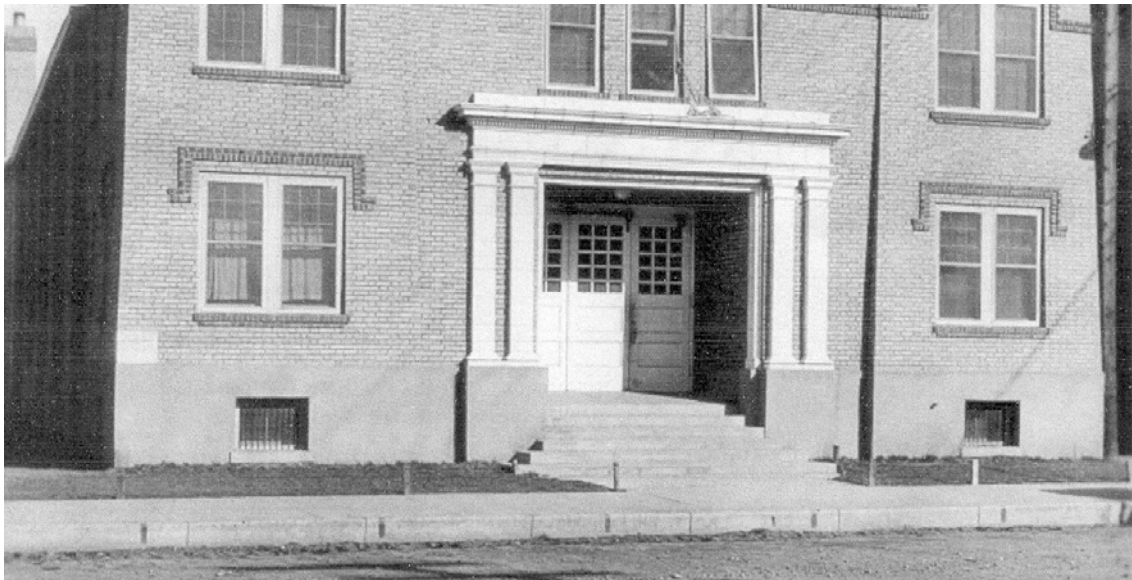
Original entry stair, detached sidewalk and planter beds; ca.1974
Photo courtesy of City of Greeley Museums, Hazel E. Johnson Collection

This was lost in 1982 when the entry was replaced by flanking stairs that ascend parallel to the main 8th Avenue façade to an elevated stoop at the front door. The planter beds are replaced by concrete sidewalk and stairs and the flanking pilasters setting on plinths are all but lost visually.

- Removing and rebuilding the entry stair in its original configuration is not technically feasible at this time as it would discharge people directly out towards the street traffic without any barrier which would create a life safety hazard. As such the original flanking planters can not simply be brought back without some other public way improvements. However, this could be done if the City agreed to provide a continuous planter at the curb line that would be the depth of a parallel parking space. This would not intrude on 8th Avenue traffic flow as there is already parallel parking to the South side of the alley and the street is sized to accommodate that width. It is unknown why there is no parallel parking in front of the Armory building. This new curb line planter would provide a pedestrian buffer that would allow for a stair similar to the original with flanking landscape planters and a detached sidewalk to be brought back.

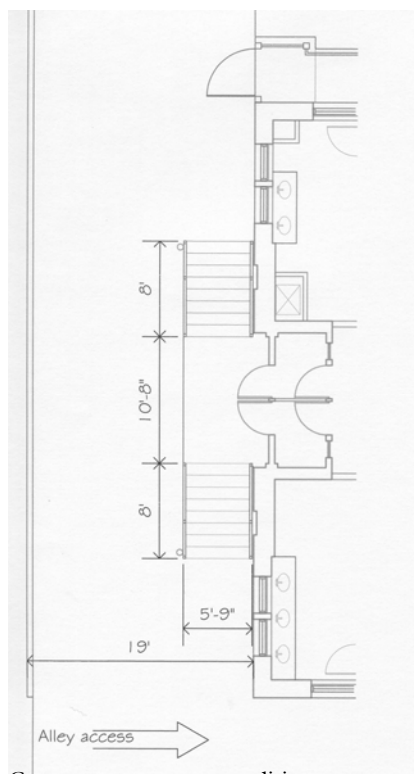
- Over time the sidewalk grade and the flow line of the curb at 8th Avenue have been lowered by about 16". It is not technically feasible to once again raise those grade levels. As a result, the new stair would be taller than the original stair by about 3 risers. In addition, today's codes require a minimum of 4' in front of out swinging doors which would thus render a 7' deep recessed stoop in lieu of the original 5' recess. And finally, today's codes will require side hand/guardrails on both sides of the stairway. Technically a center handrail would also be required as the stair is wider than 60", however, we would request a variance to that issue.

Current streetscape condition

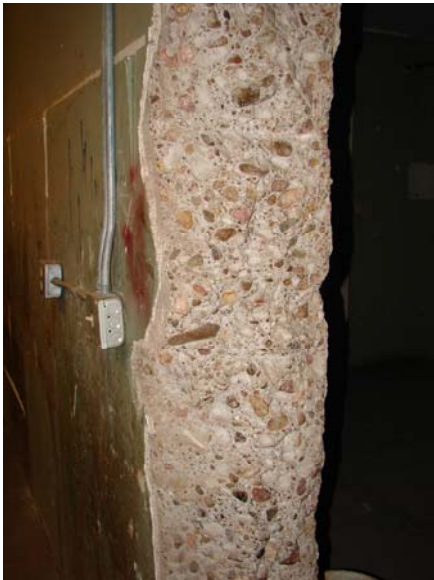
The foundation walls are 12" thick un-reinforced concrete as was observable in the basement level at an interior wall knock out located at grid 5B.

Interior foundation wall at grid 5B

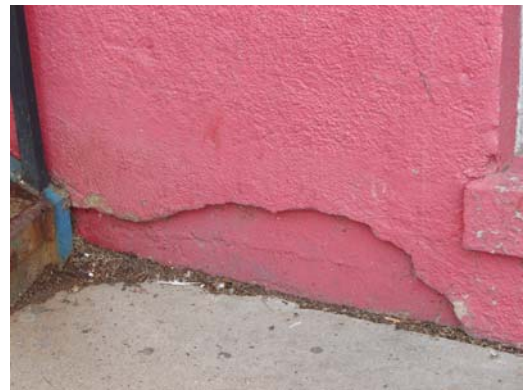
Exposed exterior foundation wall- grid 3A exhibiting some slight cosmetic cracking

The exterior foundation walls are observable for their full height on the interior and for about 5' on the exterior. This observation revealed nothing problematic with no signs of stress fractures on the interior and only a few minor locations on the exterior at windows.

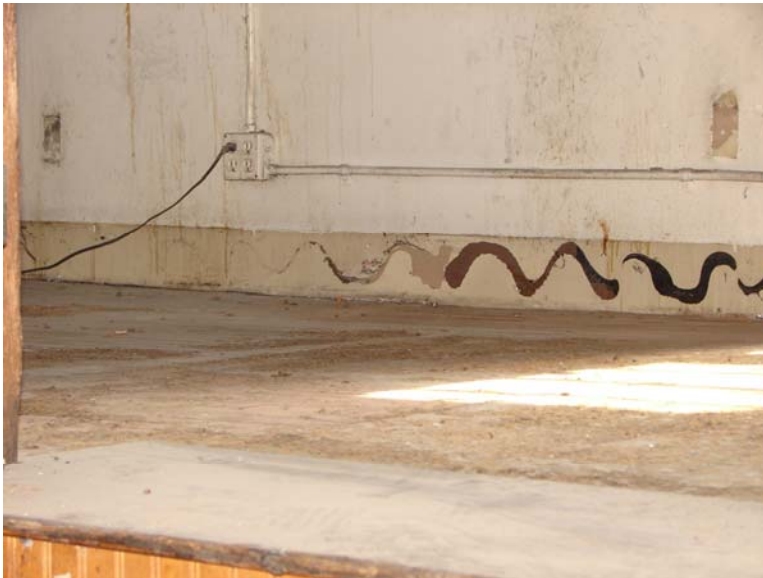
The ceiling joists at the Mechanical Room/Stage Right floor joists are 2x12's at 12" o.c. spanning E-W to a header beam at the stair opening. The connection at this header beam are simply end nailed connections at each floor joist. There is sagging of the floor noticeable from above

Stage Right wall showing signs of sagging at floor joist connections

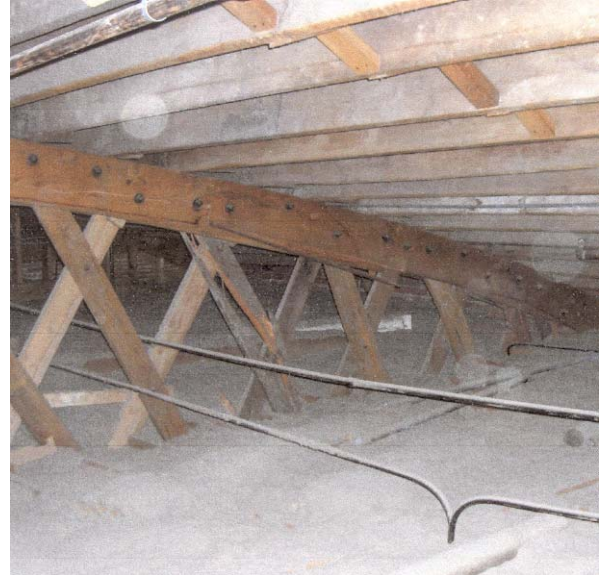
Grid G truss with visible broken structural members

This appears to be the truss line that the B-17 airplane was suspended from during the 1978 restaurant bar modifications.

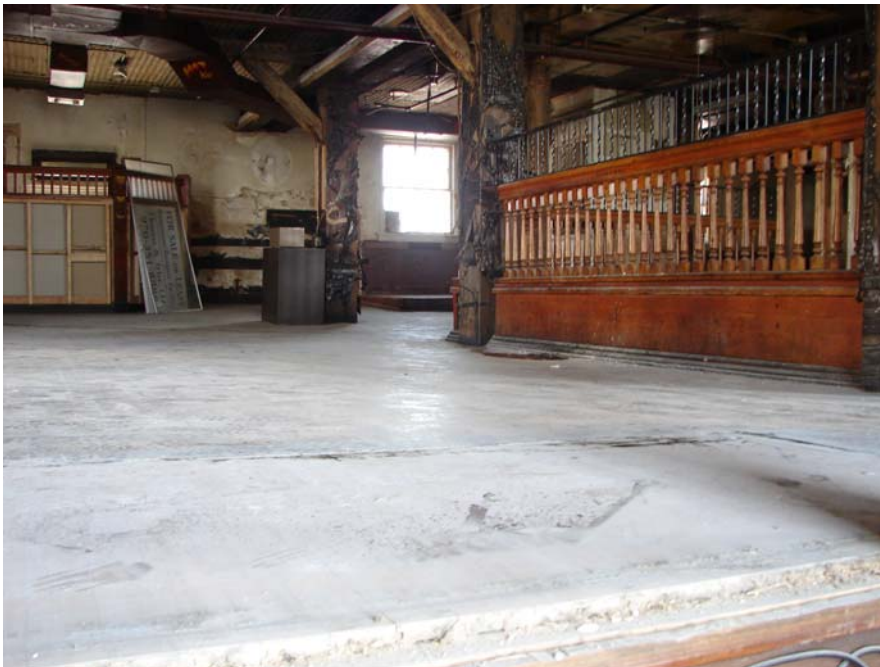
The truss along grid D is also sagging as evidenced by the suspended Mezzanine flooring sagging along this grid line. The amount of slope is visibly noticeable as viewed from floor level while ascending the stairway. Irrefutable evidence was observed as a nearby roof leak at grid C7 created a flow of water and a small pond at the low spot. Although there were no visibly broken truss members as viewed from within the attic, the deflection is enough to cause concern.

Sloping Mezzanine floor along grid D~ water in low spot visible

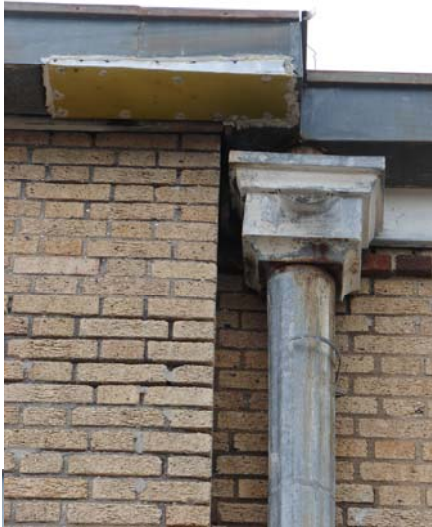
The longer E-W façades are broken up with 5 vertical pilasters arranged in a collanade fashion. Vertical drainage downspouts at each of these pilasters has leaked over the years causing the grout to wash out of many of these joints.

Water damage at grid 7D

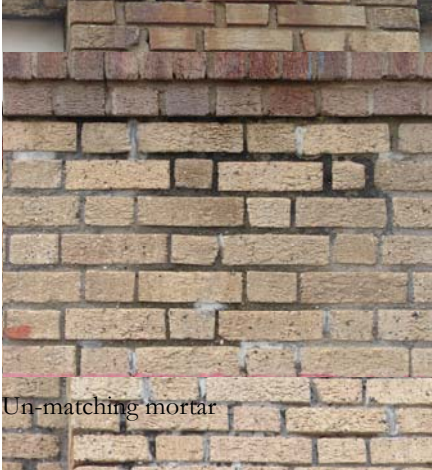
Un-matching mortar

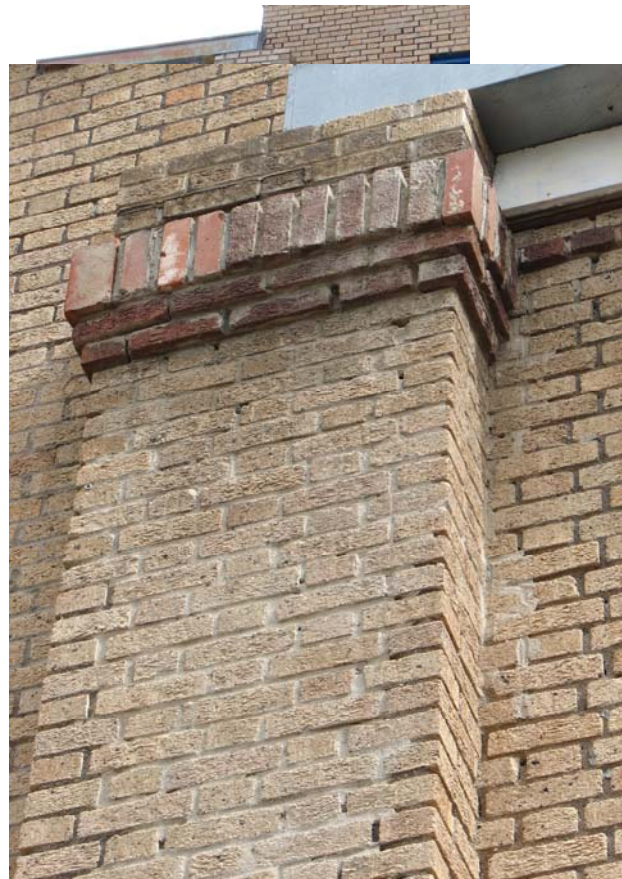
Water damage and un-matching mortar at grid 1C

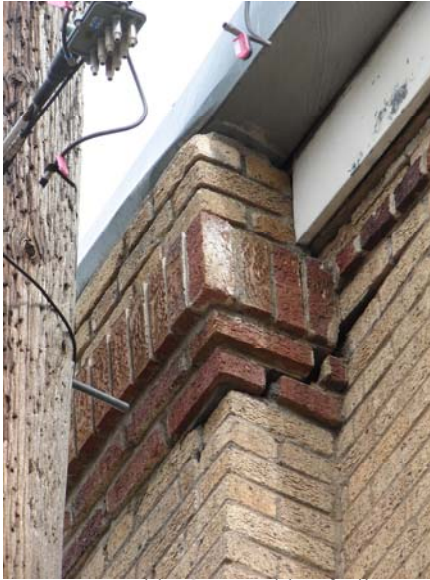
There is substantial masonry damage at truss 1G movement where structural movement described in Section 3.3 most likely caused the bottom of the truss to kick out and displace the masonry at the top of the pilaster.

Damage at grid 1G-East side of pilaster

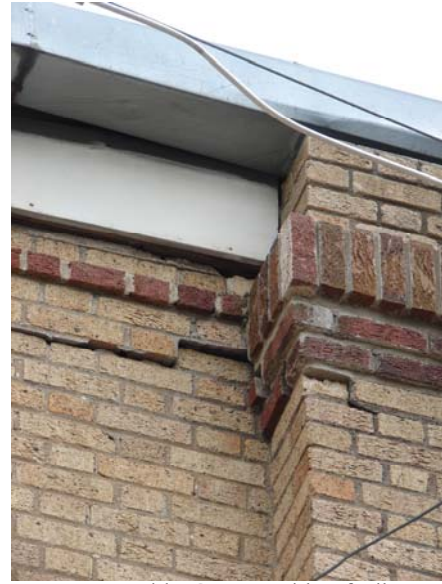
Damage at grid 1G- West side of pilaster

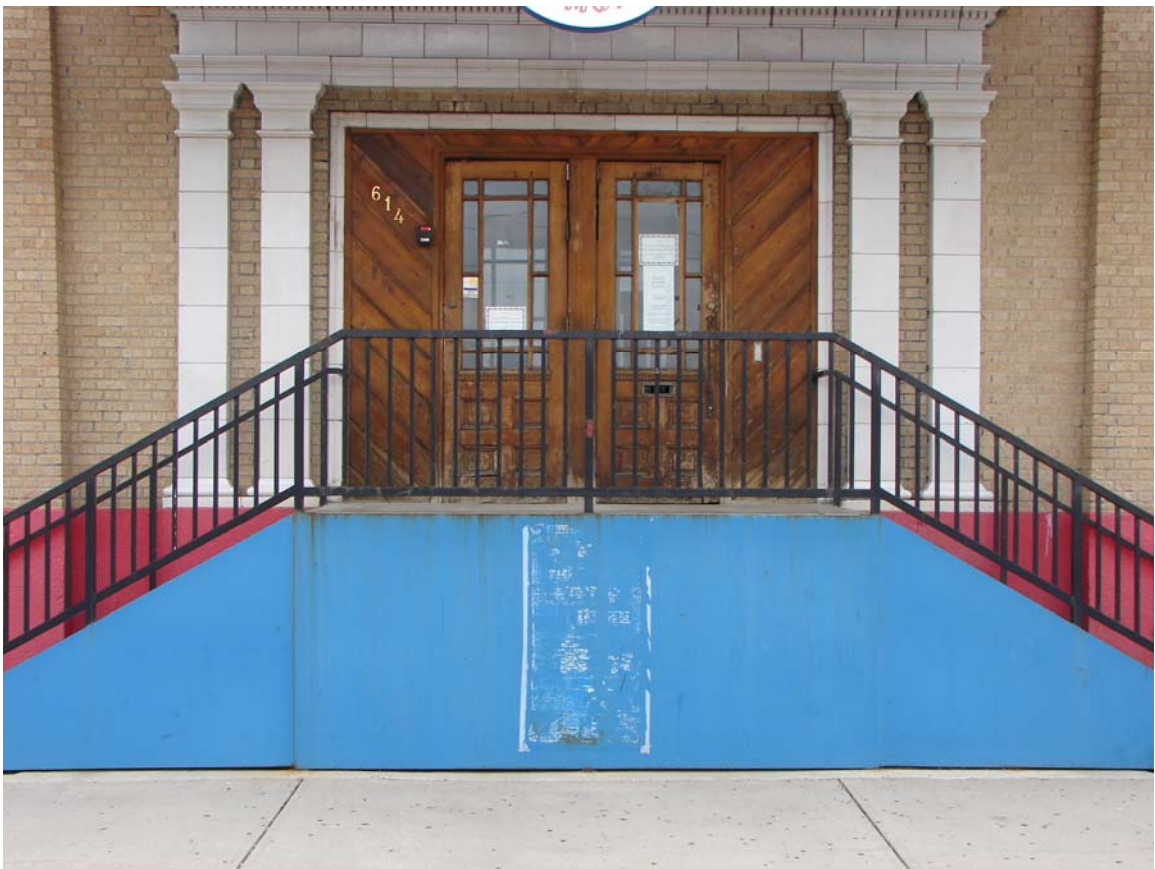
The current entry steps are not the original configuration but were added in 1978 when the restaurant filled in the recessed entry with an interior double entry vestibule predicated the need to push the entry stoop out towards the public way making side stairs necessary. In addition to the adverse effect this design has on the overall composition and historic integrity of the building, the physical condition of the concrete is deteriorating and spalling.

Current flanking entry step configuration

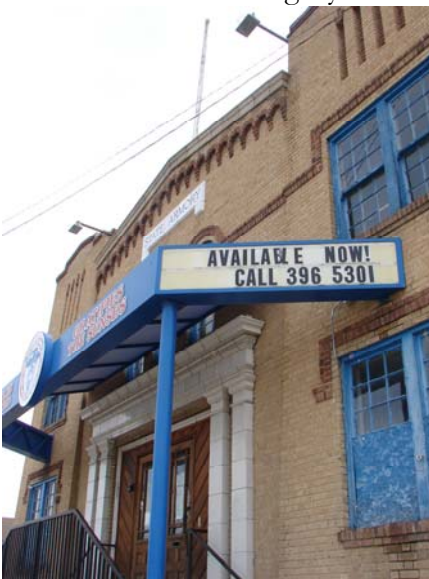
Although this sign is in good condition physically, it is an addition from 1978 that adversely affects the historic integrity of the building.

Sign ca.1978~ view from 8th Avenue

- Recommend removal of this sign and supporting posts in their entirety.
- Damaged masonry at points of connection should be patched and repaired.

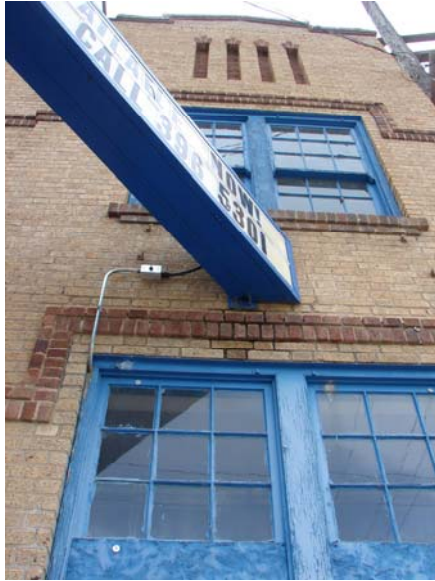
Sign connection at wall

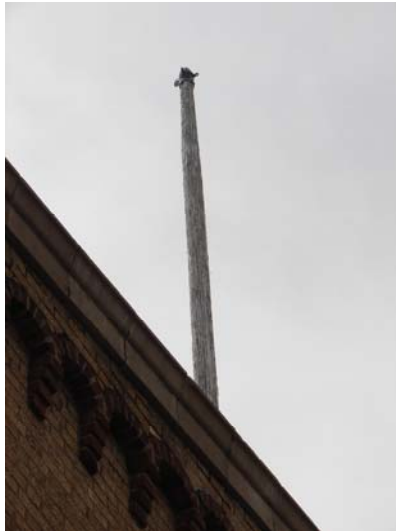
The original wood flag pole which is centered over the main entry is still intact and whole but in need of paint and working components and ropes. Old Glory has not flown here for many decades and as a critical component to the history of this place we believe it should be flown once again.

Flag pole as viewed from alley

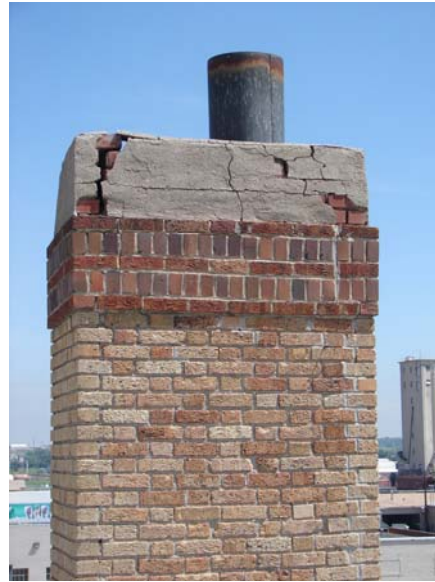
We were not able to safely access the top of this chimney for a closer investigation of the deteriorated cap at this time.

View of deteriorated cap

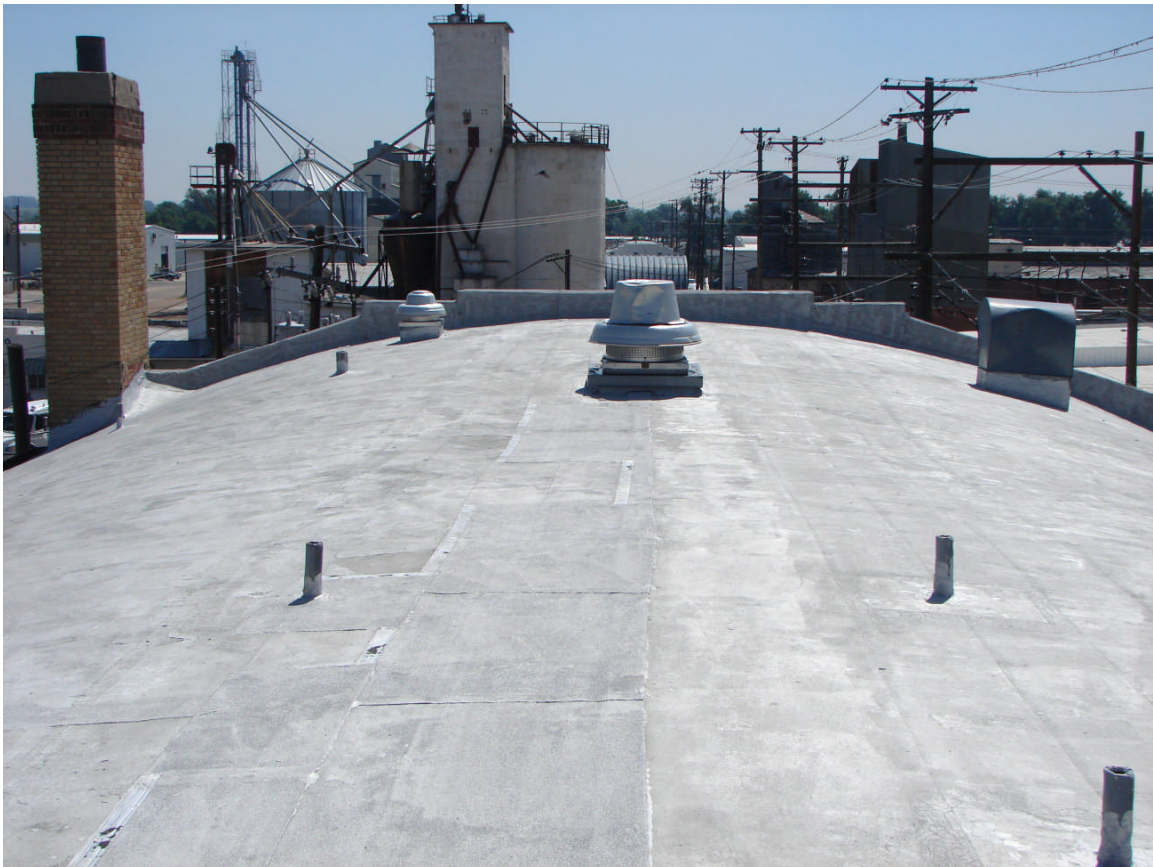
The roof is in disrepair at this time. Extensive buckling and cracking is evident across the surface. The entire surface contains seamed patches on top of seamed patches.

Vaulted roof looking East along apex of curve

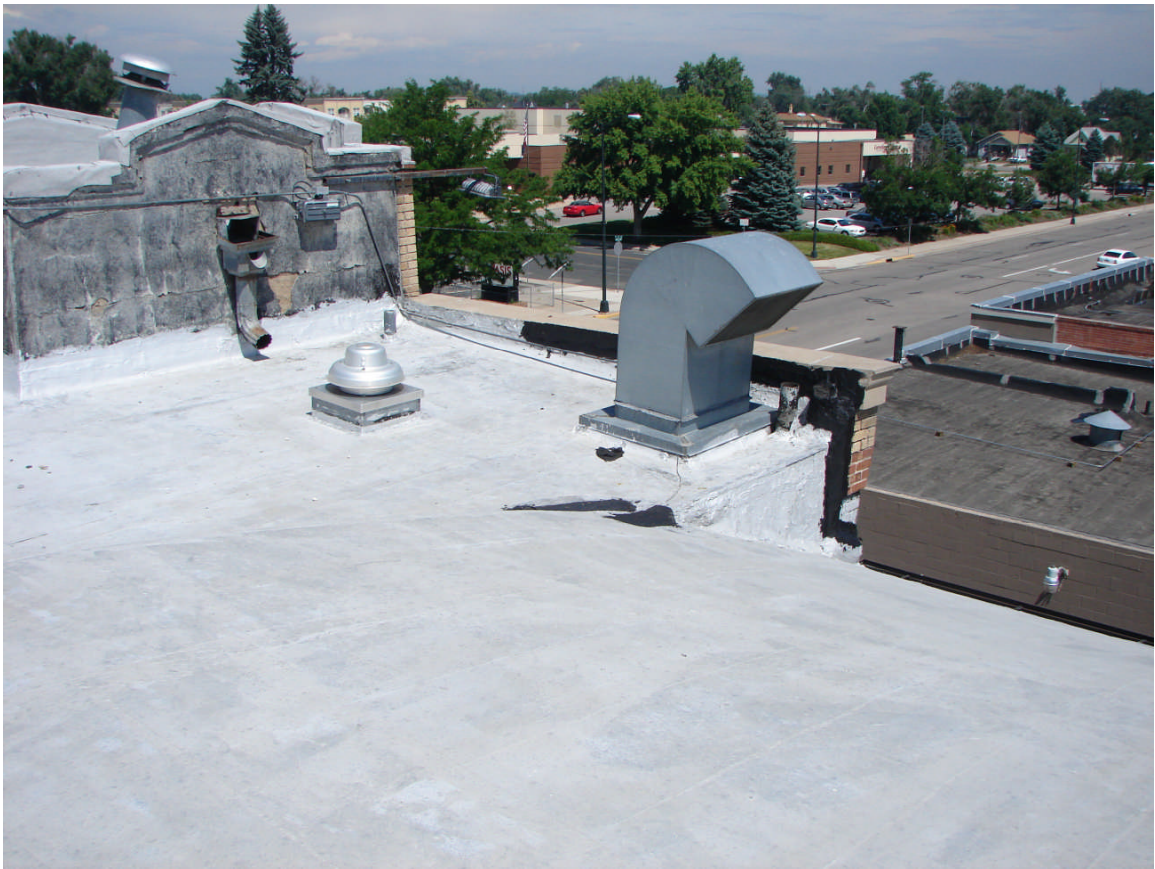
There is an active leak in the roof at grid 7C where the vaulted roof meets the cripple wall at the flat roof transition. This leak was recently patched in a temporary fashion by applying tar to fill the gaps. As there was active water in the stair well of the building at this location at the time of this analysis it is unknown if the patching is holding and water tight.

Location of leak where fresh tar has been applied at the vertical transition

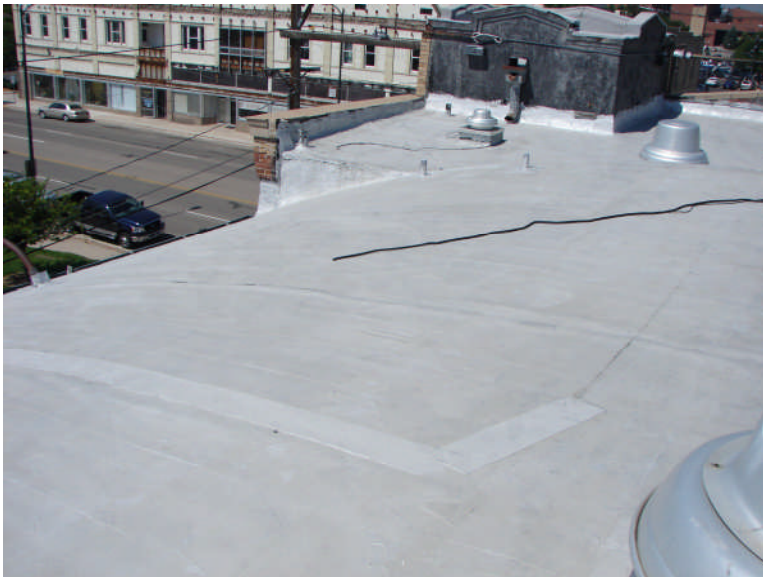
Patching and buckling of roofing felts

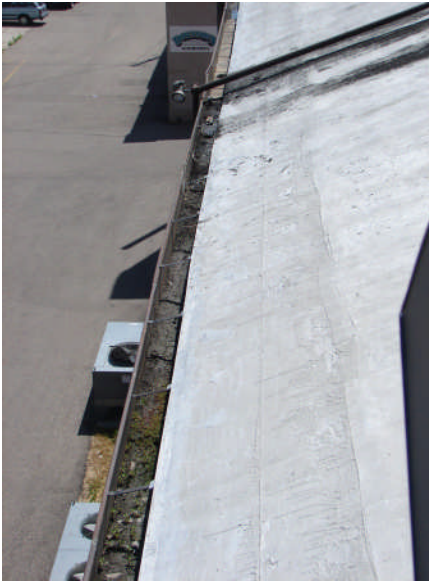
The drainage system is handled by gutter and downspouts along the North and South sides of the roof. The gutter and downspout system exhibits advanced corrosion at seams and joints. The angled and articulated downspout arrangement on the North façade (see below) is very susceptible to ice blocking and there is evidence of leaking at the joints. There is clear evidence of mortar erosion in the masonry behind and below this downspout and it is unknown to what extent the erosion predates the current downspout arrangement. Only one original scupper and downspout remains at grid 7E. The paint color on those elements is deteriorating but white paint is still visible. The original soldered joints of the old scupper and downspout have failed and are leaking.

Gutter along North facade~ grid 7

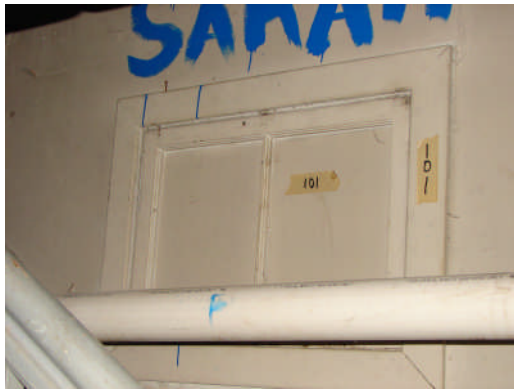
Window#55 (note this window is not visible from the exterior as it is encased below the ramp)

Recommendations: Remove vegetation and trapped debris. Prep, caulk and re-paint frame white. Repaint bars black. If mechanical is removed then restore original window.

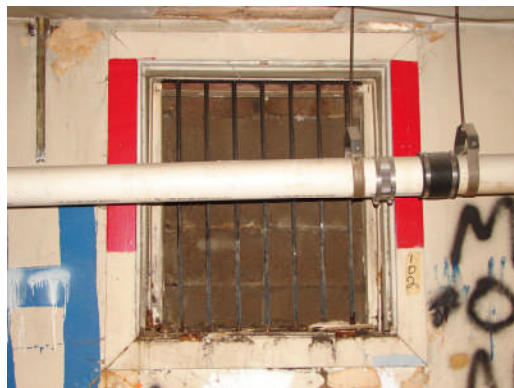
Window#56 (note this window is not visible from the exterior as it is encased below the ramp)

Recommendations: If the ramp is removed in the future, then this window should be accessed at that time.

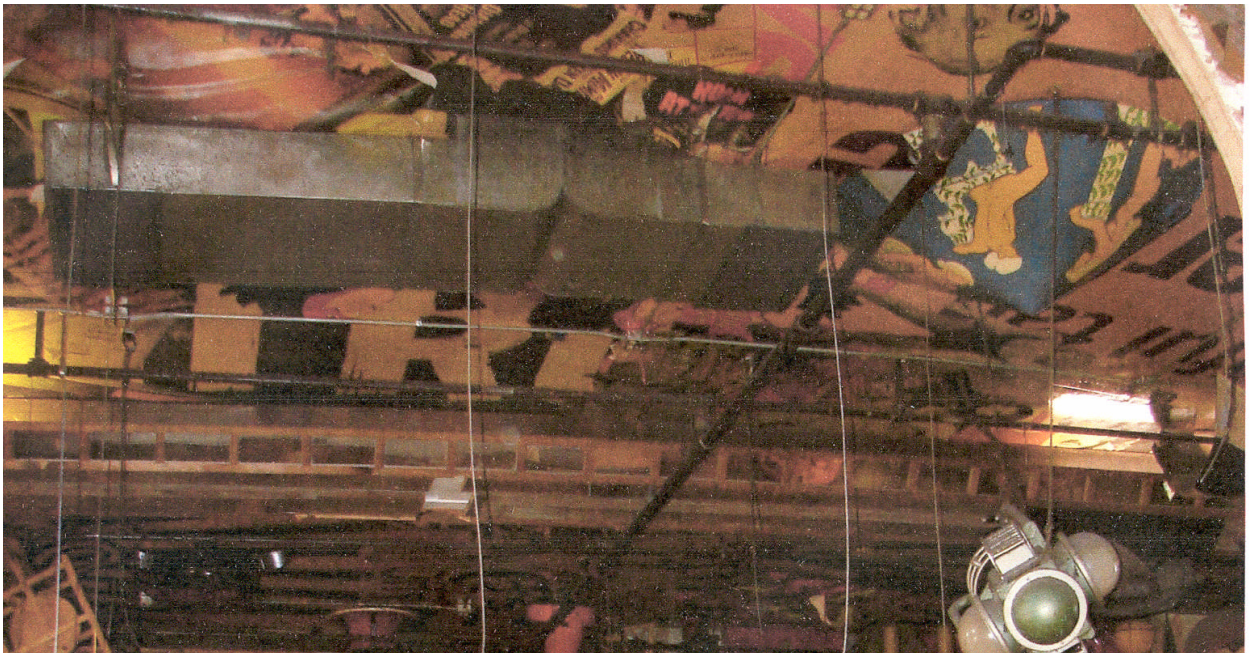
Current ceiling chaos
