G R E E L E Y A R M O R Y
6 1 4 8 t h A v e n u e
G r e e l e y , C o l o r a d o 8 0 6 3 1

HISTORIC
STRUCTURE
ASSESSMENT
2009-HA-022

1 0 . 1 . 2 0 0 9

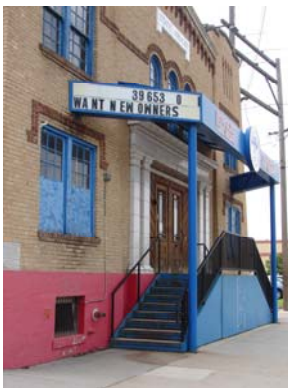
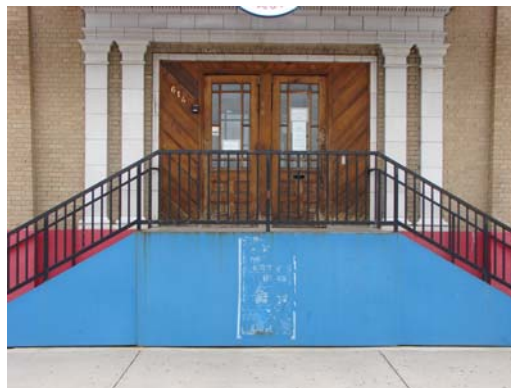
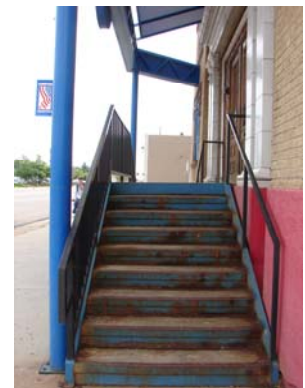
This was lost in 1982 when the entry was replaced by flanking stairs that ascend parallel to the main 8th Avenue façade to an elevated stoop at the front door. The planter beds are replaced by concrete sidewalk and stairs and the flanking pilasters setting on plinths are all but lost visually.

Entry sidewalk, ascending stairway and street landscape condition today ca. 2009

- Removing and rebuilding the entry stair in its original configuration is not technically feasible at this time as it would discharge people directly out towards the street traffic without any barrier which would create a life safety hazard. As such the original flanking planters can not simply be brought back without some other public way improvements. However, this could be done if the City agreed to provide a continuous planter at the curb line that would be the depth of a parallel parking space. This would not intrude on 8th Avenue traffic flow as there is already parallel parking to the South side of the alley and the street is sized to accommodate that width. It is unknown why there is no parallel parking in front of the Armory building. This new curb line planter would provide a pedestrian buffer that would allow for a stair similar to the original with flanking landscape planters and a detached sidewalk to be brought back.

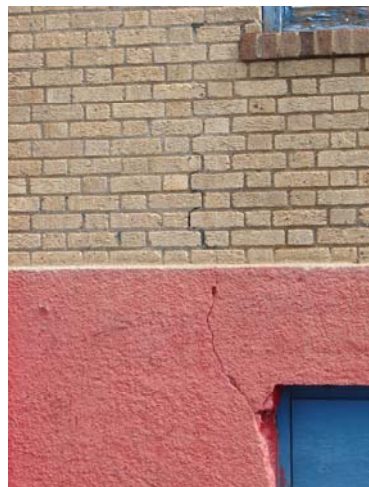
The exterior foundation walls are observable for their full height on the interior and for about 5' on the exterior. This observation revealed nothing problematic with no signs of stress fractures on the interior and only a few minor locations on the exterior at windows.

Exterior foundation wall crack at grid 1B (typical of 6 locations, all at window corners)

The cause of the foundation crack shown above at grid 3A appears to be from construction damage caused when the entry stair was modified and installed at this location.

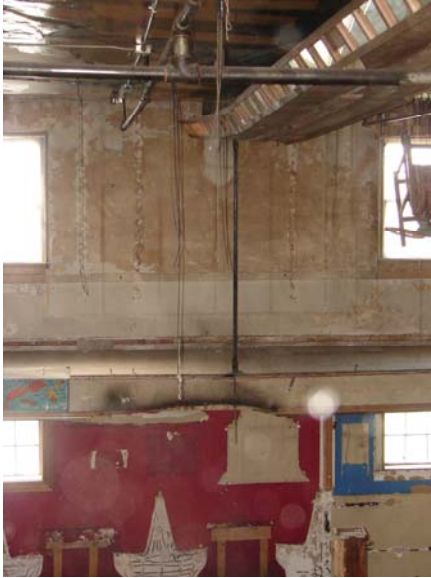
The roof truss along grid G is visibly sagging as viewed from the open room at Level 1 below. Inspection from within the attic space, although not exhaustive in nature, revealed that this truss has a busted top cord along with 4 web members close to the exterior wall along grid 1.

Grid line G sagging truss

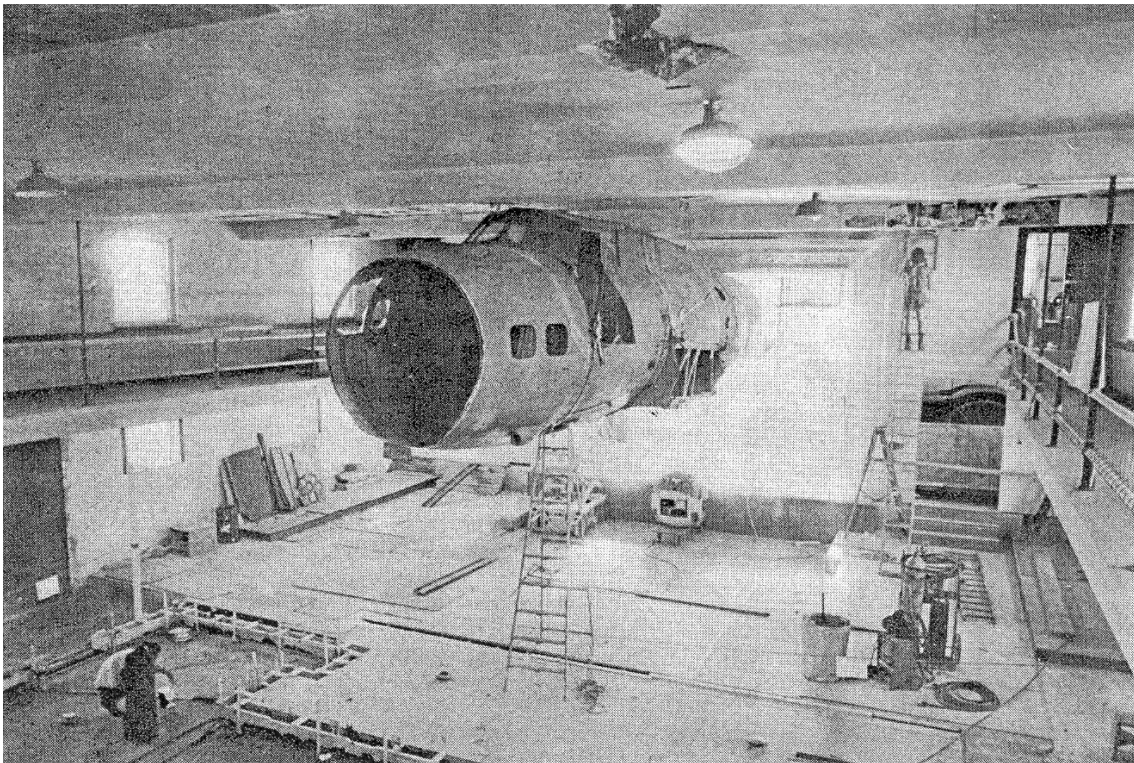
This appears to be the truss line that the B-17 airplane was suspended from during the 1978 restaurant bar modifications.

Photo ca.1978 showing installation of B-17 plane suspended from truss G line

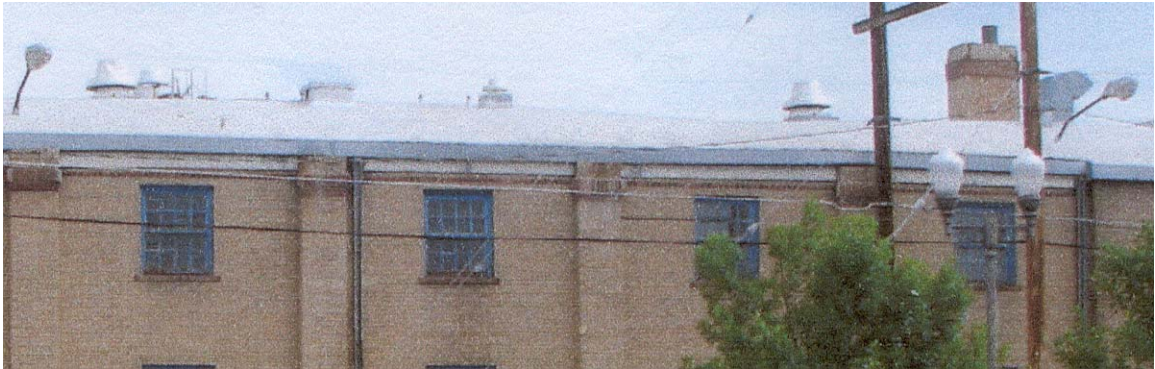
The amount of fall in the truss is highly visible from the roof and appears to be substantial~8", something like that. There is noticeable deflection in the roof that can be seen both from the roof and also from the ground level.

Deflection in roof at grid G as viewed from South parking lot
Scribe a straight line along the apex of the roof curve and you will see daylight along grid G
(just left of the utility power pole in this picture)

This truss deflection is also causing the Mezzanine which is suspended from this truss to noticeably sag.

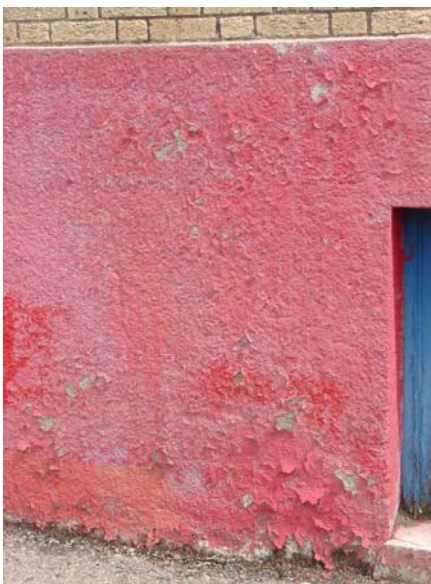
The exterior walls are all set up on a 5' high stucco concrete base, which is the extension of the basement foundation walls. The stucco texture on those walls is fairly rough and monolithic in nature. The condition of the base is in fair condition with about 6 locations where there are movement cracks aligning with window corners. These cracks are not of structural concern, but need to be filled to avoid migration of water into the wall. It is believed that the building is no longer in flux and that maybe the stresses developed at the same time truss D was broken. The location of the cracks also coincides with where the first floor joists are bearing on the wall. With light frame wood joist framing there is probably some deflection and bounce going on. This too could be the cause of the cracks.

Typical concrete base

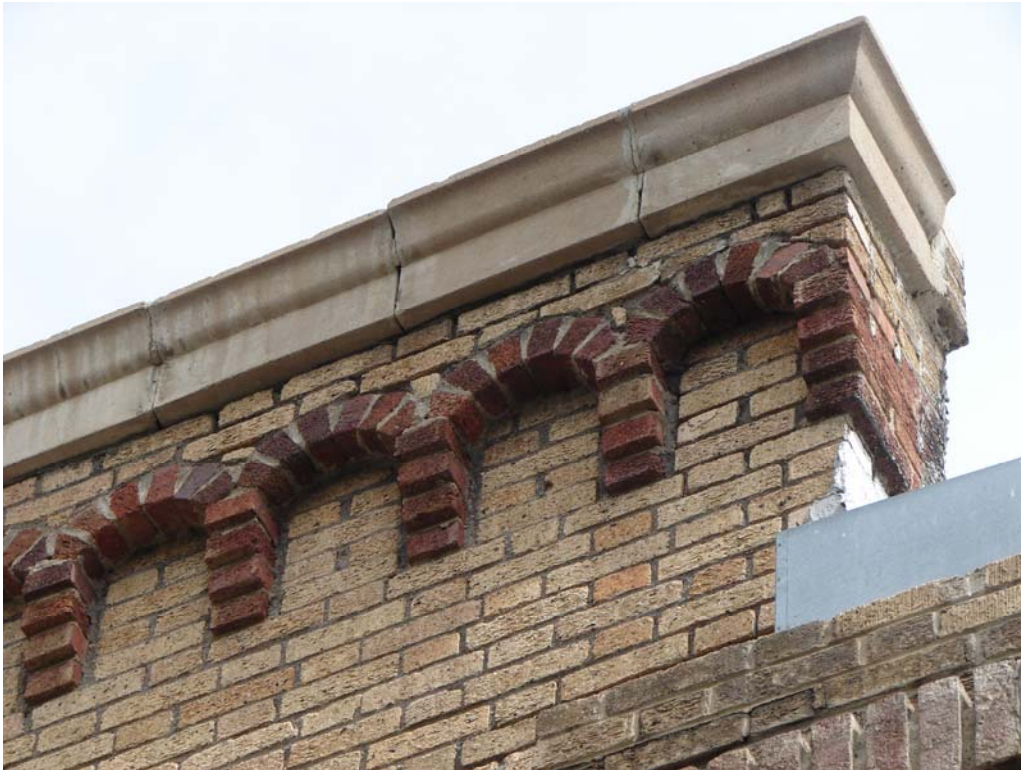
Parapet at Towers

This main entry detail is continued on both the North and South façade parapets as the towers step down giving way to the long horizontal façade of the vaulted portion of the structure. The cap stones are in need of tuck pointing and cleaning throughout these parapet locations.

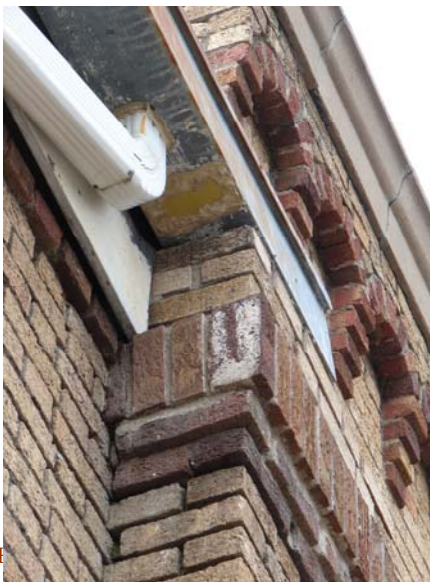
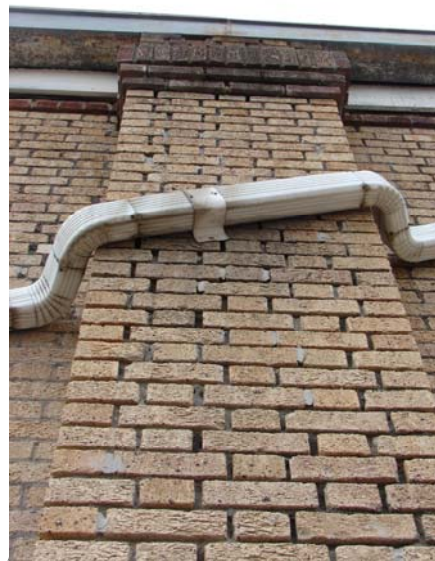
Water damage at grid 7C

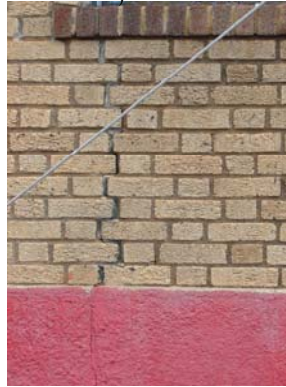
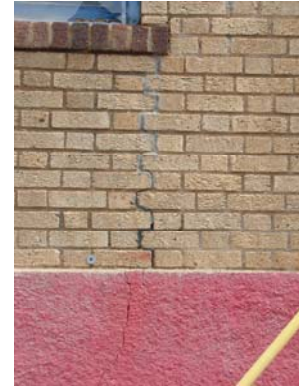
Cracks at window corners- typ. of 6
Grids E-H on both North and South Facades

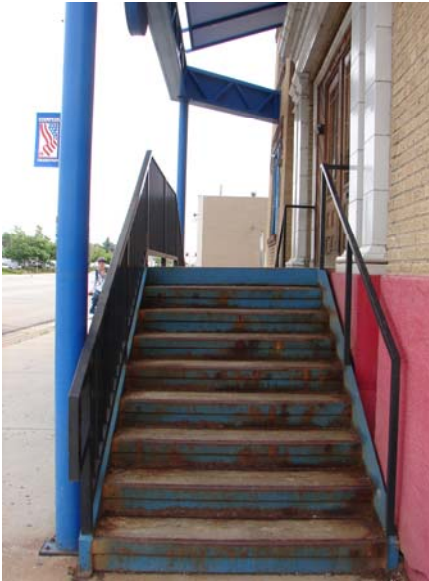
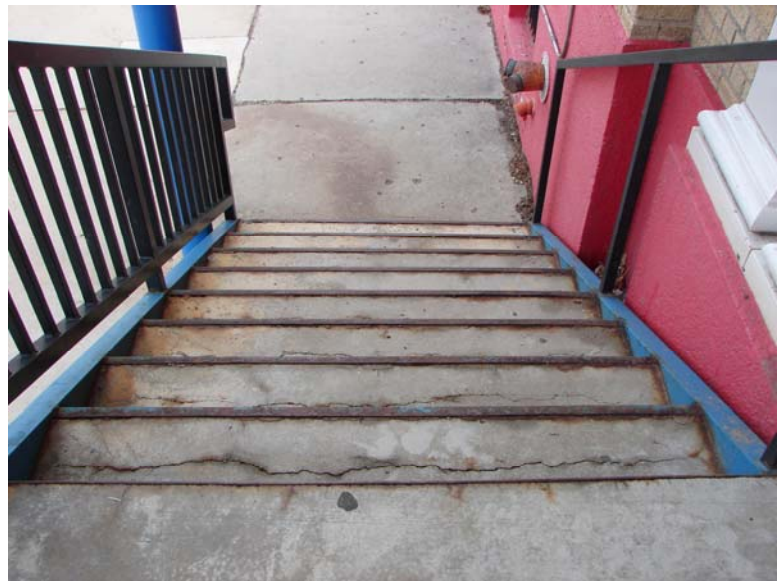
Steps cascading towards the South

Steps as viewed from entry stoop

- Recommend complete removal and replace with new concrete stairs similar to the original stair configuration. This requires also restoring the recessed entrance. Reference section 3.1 discussion.

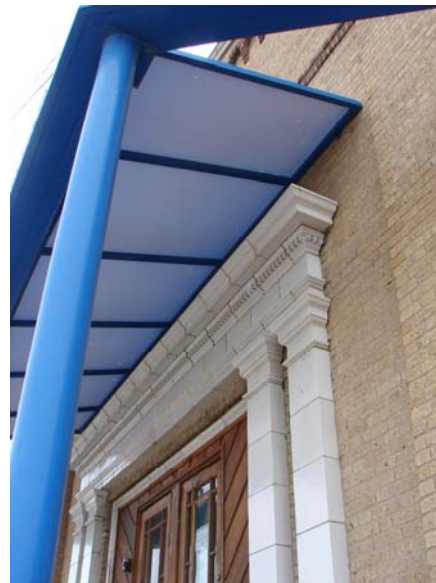
Although this sign is in good condition physically, it is an addition from 1978 that adversely affects the historic integrity of the building.

Sign canopy over historic entry surround

- Recommend removal of this sign and supporting posts in their entirety.
- Damaged masonry at points of connection should be patched and repaired.

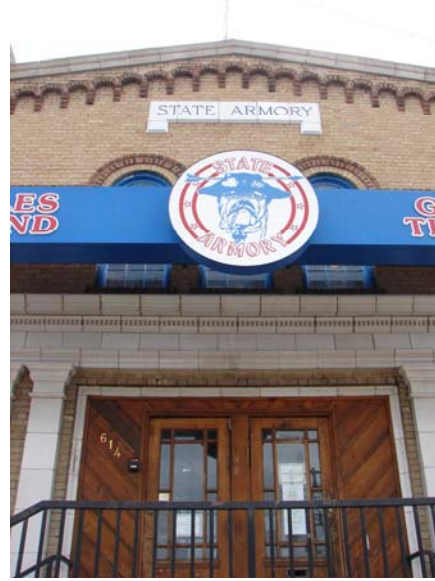
Center sign band obstructing historic windows

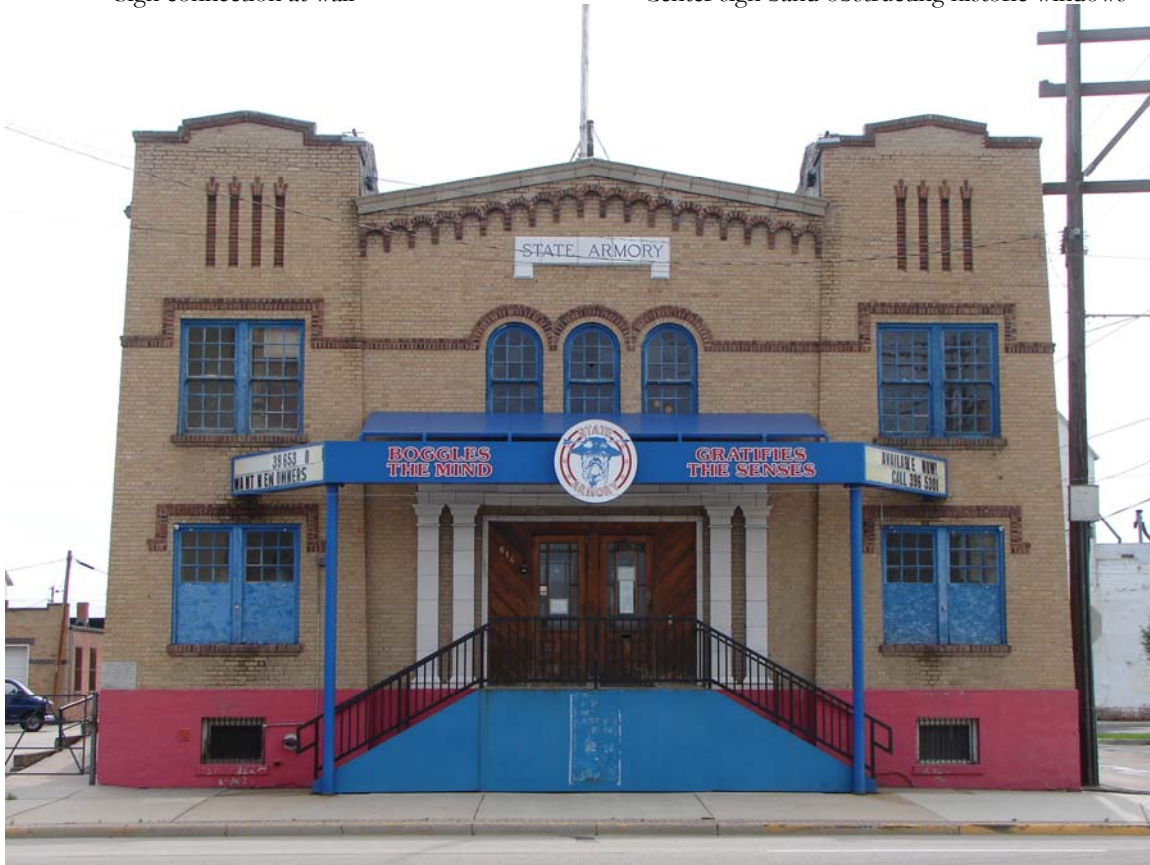
Current sign in context/disharmony with historic facade

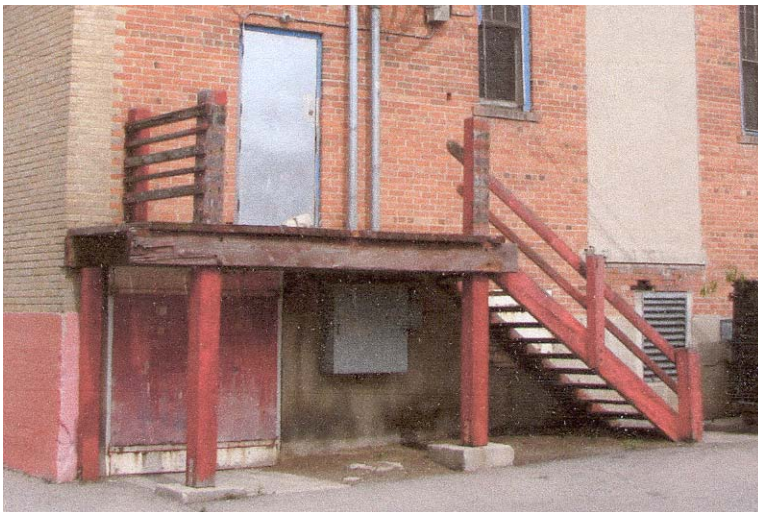
The original loading dock was removed in 1978 and replaced by a heavy timber framed wood dock which allowed for direct access into the back of Stage Left (grid 1I). The original loading dock appears to have been lower and at the height of the concrete base. The memory of that dock still exists as its ghost is cast into the concrete. The condition of the 1978 dock is in complete disarray with deteriorated wood members and missing guardrail components. Although the current dock is located in the 'back', East Alley side, it is still highly visible from the primary approaching access from 8th Avenue and the parking lot to the South.

Current loading dock, ca. 1978 renovation

- Complete removal of this dock and replace it with a lighter framed, and visually lighter steel grate flooring system, steel posts and metal guardrail system. The guardrail should have lift out sections to make loading more convenient.

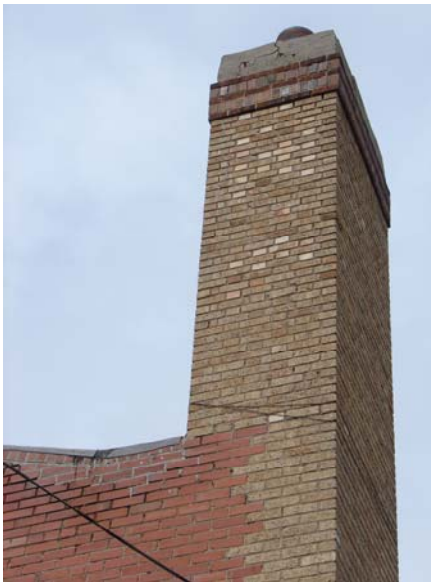
The original coal fired furnace flue is in the form of a vertical masonry chimney located on the North East corner at grid 7I. This chimney rises 54 courses (12") above the gutter roof line where a red brick corbel and plastered cap top it off. The masonry of the entire chimney is in good condition but the plaster portion of the cap is cracked, missing some sections and in general falling apart. A close inspection of historic photographs show that the chimney enclosure originally had this plaster cap and that it was not added at a later date.

This chimney is currently being used by Air Handler No.2 as a conduit for its flue to penetrate from the basement to the sky and as such a modern flue pipe is protruding out of the top about a foot. Inspection from inside did not indicate the presence of a liner in the shaft.

View of Chimney from East Alley

- Plaster patch and repair to solidify the top enclosure to mitigate any further damage and deterioration.
- By a safe means (lift) access the top of the chimney for further inspection. Further recommendations may be forthcoming as a result of that inspection.
- Line the chimney shaft to mitigate deterioration of masonry by flue gasses.

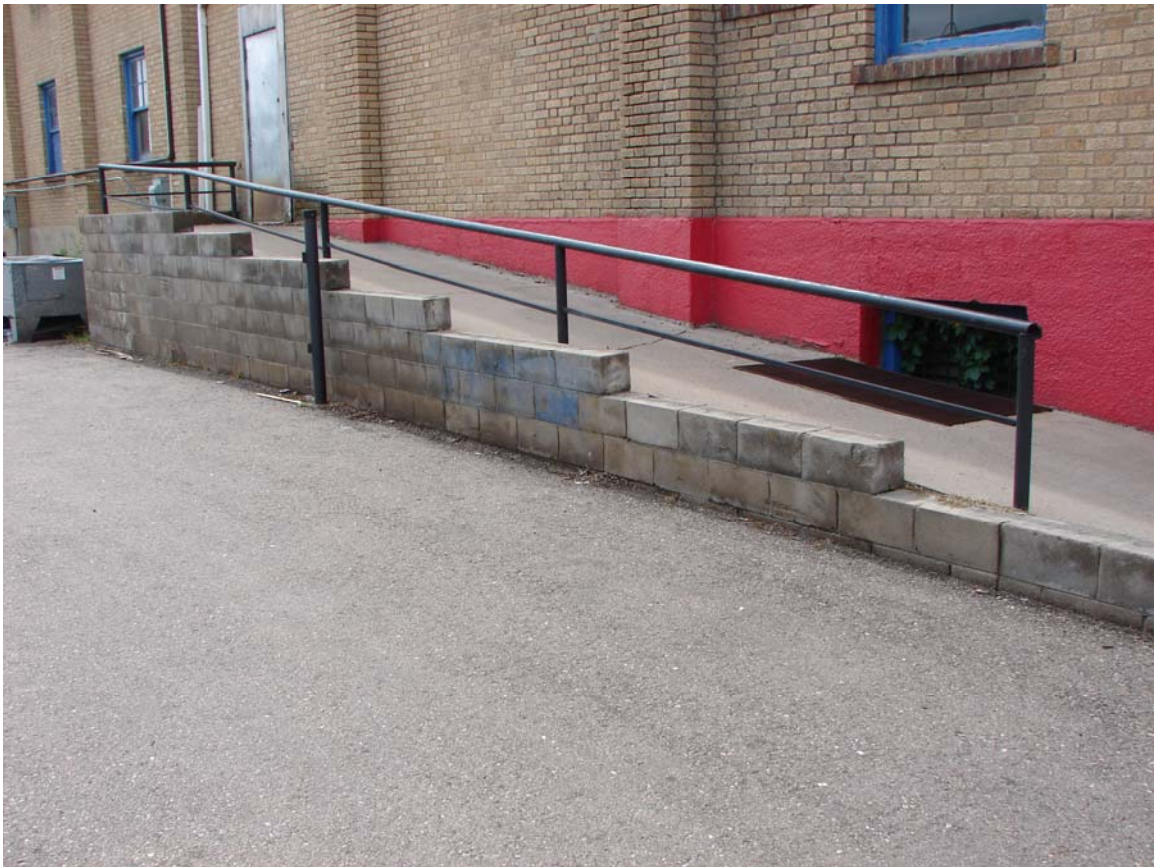
In 1978 an accessible ramp was added along the North façade extending from grid 7A to 7E (about 43'). This was done to provide an accessible means to enter the restaurant. By today's definition and standards for accessibility, this ramp is not technically 'accessible'. As such it is in poor condition as it is no longer performing its intended purpose~ it is not meeting today's regulatory standards for accessibility. Reference section 4.5 for further discussion about that issue.

We give it a 'poor condition' rating due to that situation but in addition, it's physical state is in 'fair condition' at best. The concrete block walls and concrete slab are showing early signs of wear and deterioration.

Ramp viewed from North Alley

- Complete removal and re-build to code. Reference section 4.5 for in depth discussion about requirements to meet today's standards and further recommendations about the replacement ramp.

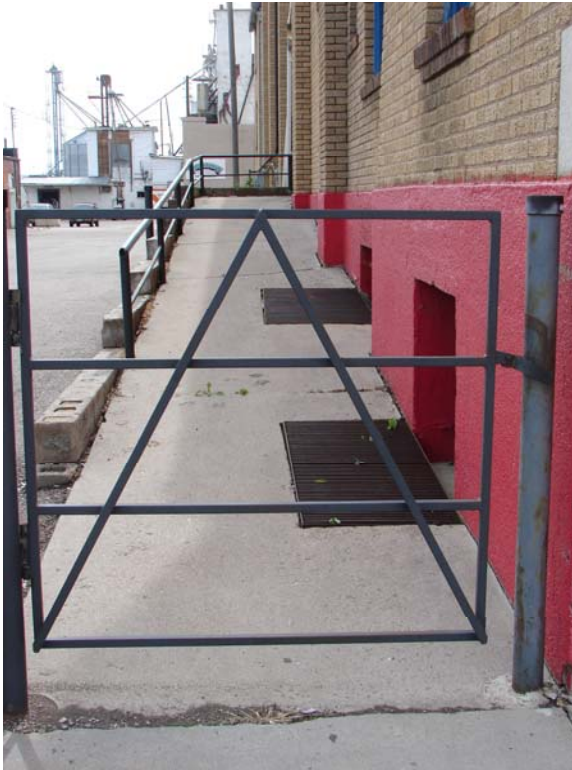
Ramp viewed from 8th Avenue sidewalk
Avenue

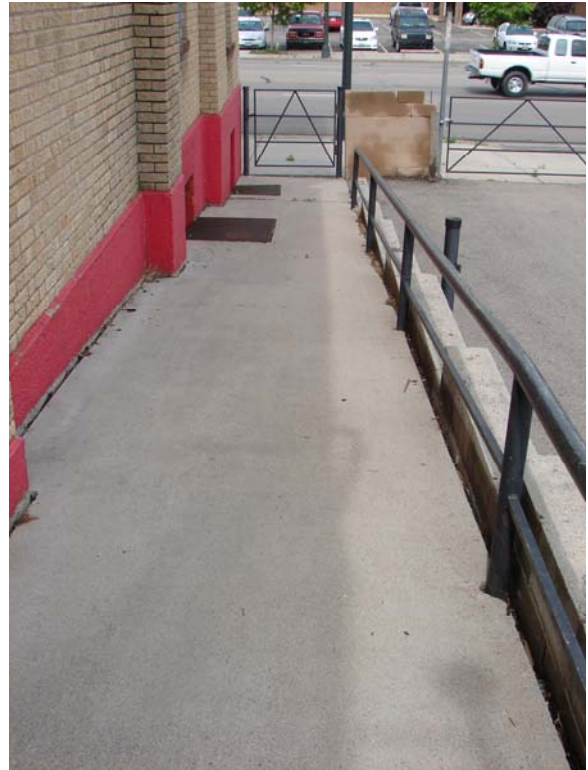
View from top of ramp looking towards 8th

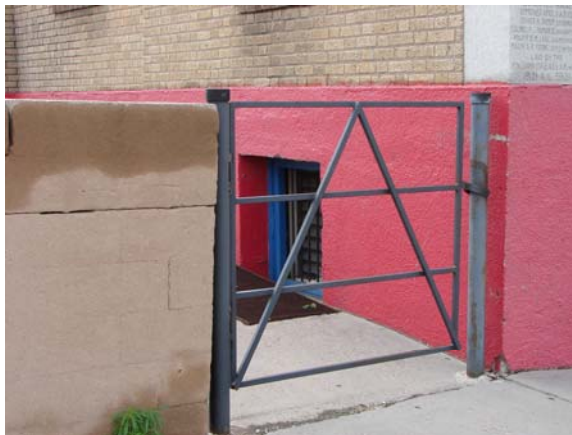
Ramp at 8th Avenue sidewalk connection

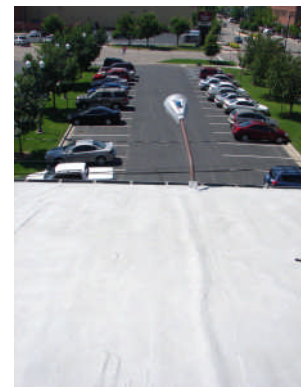
The roof is in disrepair at this time. Extensive buckling and cracking is evident across the surface. The entire surface contains seamed patches on top of seamed patches.

Buckling at grid D

- Remove existing felt and tar roofing system down to the wood decking. Per IBC Section 1510.3 'New roof coverings shall not be installed without first removing all existing layers of roof coverings where any of the following conditions occur'.....The condition that applies in this situation is that 'the existing roof has deteriorated to the point that it is not adequate as a base for additional roofing.'

- Level out roof decking along truss lines D and G~ reference Section 3.3
- Verify existing roof sheathing is in compliance with manufacturer's recommendations. Note that the existing decking are planks that are butt jointed and as such there are some slight gaps visible. Provide a top protection board if deemed necessary by manufacturer's product installation and warranty requirements.

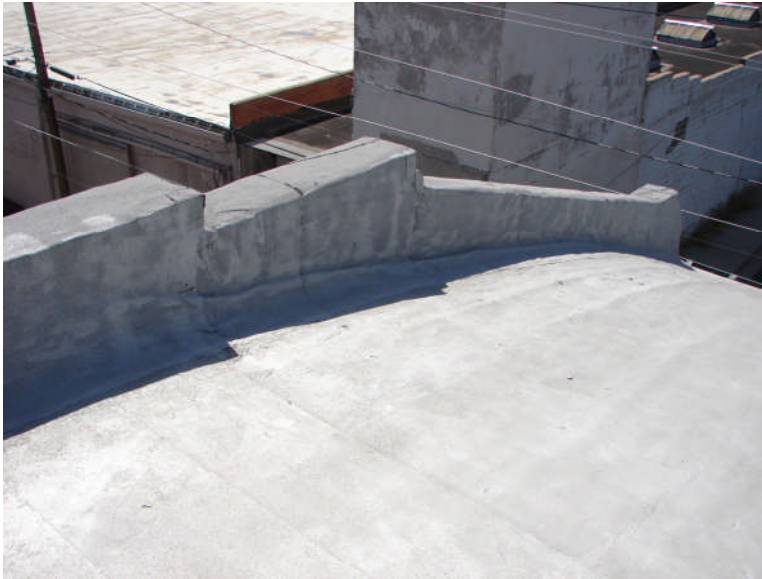
Parapet condition along East transition at vault

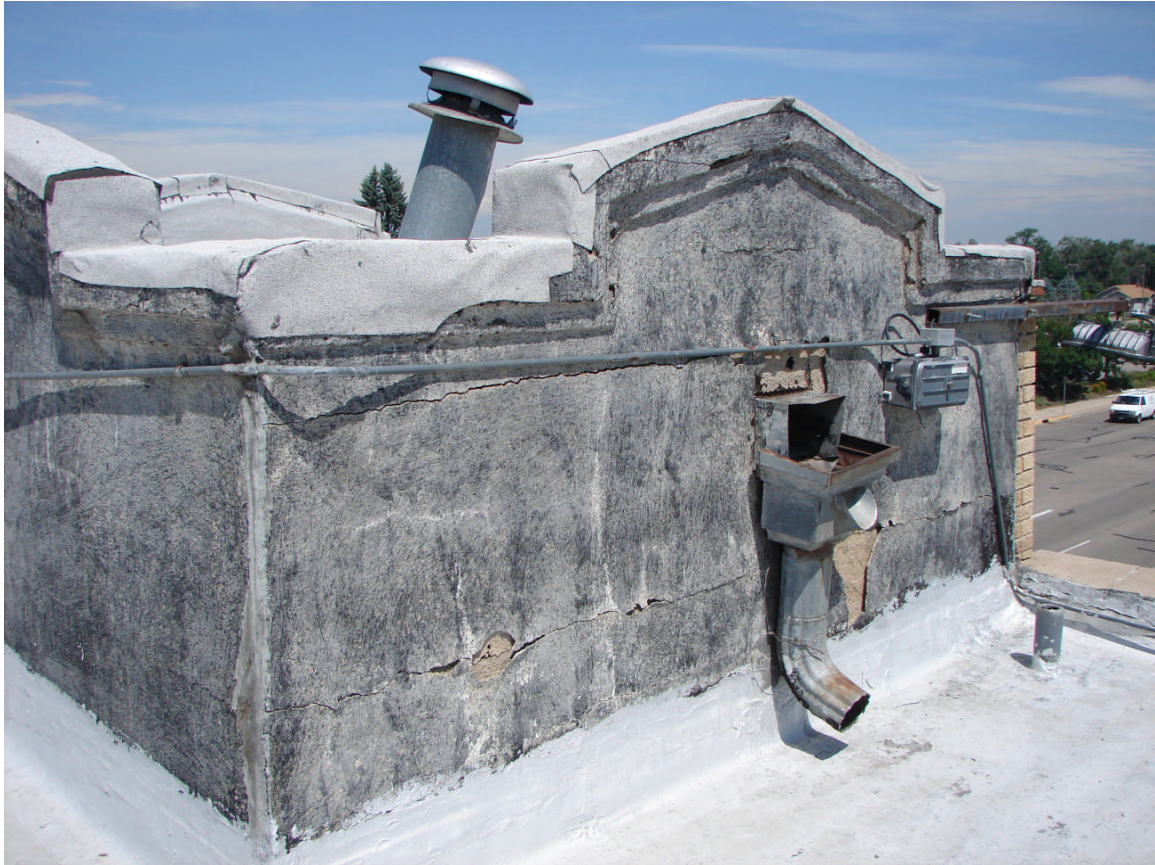
The flat roof portion was re-done in 2007 by Williams and Son as a 3 ply built up roof. It appears to be holding out the water at this time. It does not appear that the transition of the flat roof membrane to the parapet vertical walls was appropriately addressed in 2007 during the re-roofing. The parapets are covered by layers of asphalt in a very random patchwork type of fashion in lieu of continuous membrane that is flashed and counter flashed with lapping membrane material.

North Tower interior parapet walls

- Remove existing roofing materials down to roof sheathing.
- Re-roof with new fully adhered single ply membrane system as previously noted
- Greater slopes and positive drainage to all scuppers should be achieved. Since the attic is fully insulated the tapers and crickets can be framed with plywood in lieu of insulation boards. Either option would be acceptable.

- Run membrane up the back side of the parapet walls and terminate below the cast concrete caps with a termination bar. At masonry parapets extend membrane to top of wall and terminate with a termination bar that is set back far enough not to be visible from the ground. At interior tower walls, run membrane up and over wall continuously. Flash and counter flash with membrane.

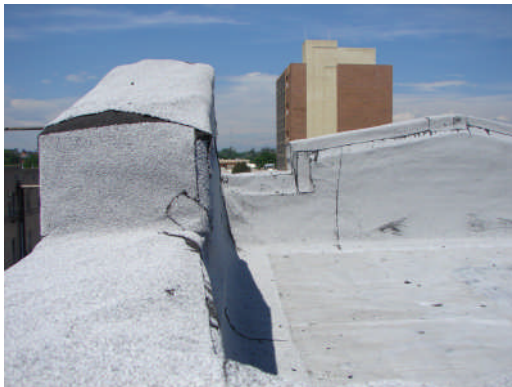
South Tower exterior parapet walls

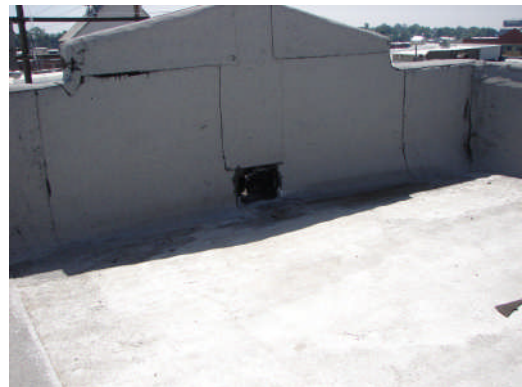
Typical Tower flat roof and scupper inlet

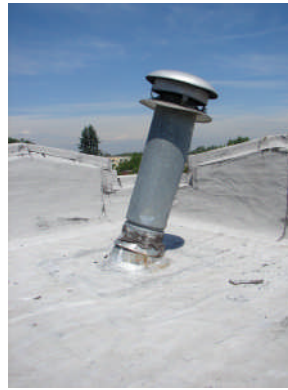
Mechanical flue penetration

- Boot flash all pipe penetrations
- Boot flash mechanical flue penetration and reset so pipe is vertical. Re-support below or provide stabilizer guy wires as necessary.
- Remove pole mounted light fixtures on roof. Replace with wall mounted lights below if additional illumination of alleyway is required.

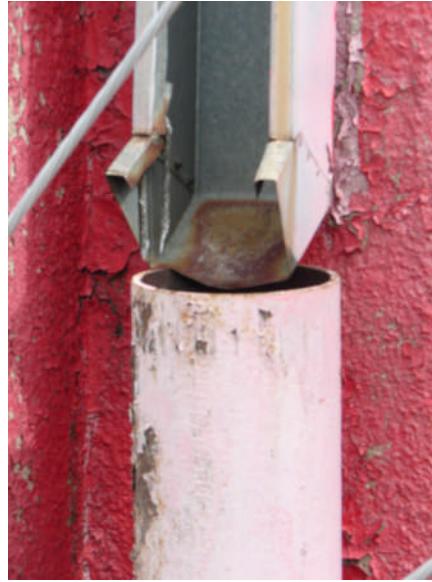
Downspout connection to storm~ grid 1H

The drainage system is handled by gutter and downspouts along the North and South sides of the roof. The gutter and downspout system exhibits advanced corrosion at seams and joints. The angled and articulated downspout arrangement on the North façade (see below) is very susceptible to ice blocking and there is evidence of leaking at the joints. There is clear evidence of mortar erosion in the masonry behind and below this downspout and it is unknown to what extent the erosion predates the current downspout arrangement. Only one original scupper and downspout remains at grid 7E. The paint color on those elements is deteriorating but white paint is still visible. The original soldered joints of the old scupper and downspout have failed and are leaking.

- Replace corroded gutter system with new seamless gutters at time of reroofing. White (white to match original which is the historic color) pre-finished products are preferable versus field painted.
- Replace scuppers and downspouts with components similar to the original pieces still in place at grid 7E.
- Refurbish collector head and downspout at grid 7E and paint white.
- Replace downspout at grid 7C/7D with a collector head and vertical drain which extends into a through culvert under ramp below. Reference section 4.5 for potential ramp modifications which make this more feasible to accomplish.
- Freeze protect the entire gutter and downspout system with heat tape continuous through gutters and down into downspouts to point of discharge to prevent ice damming.

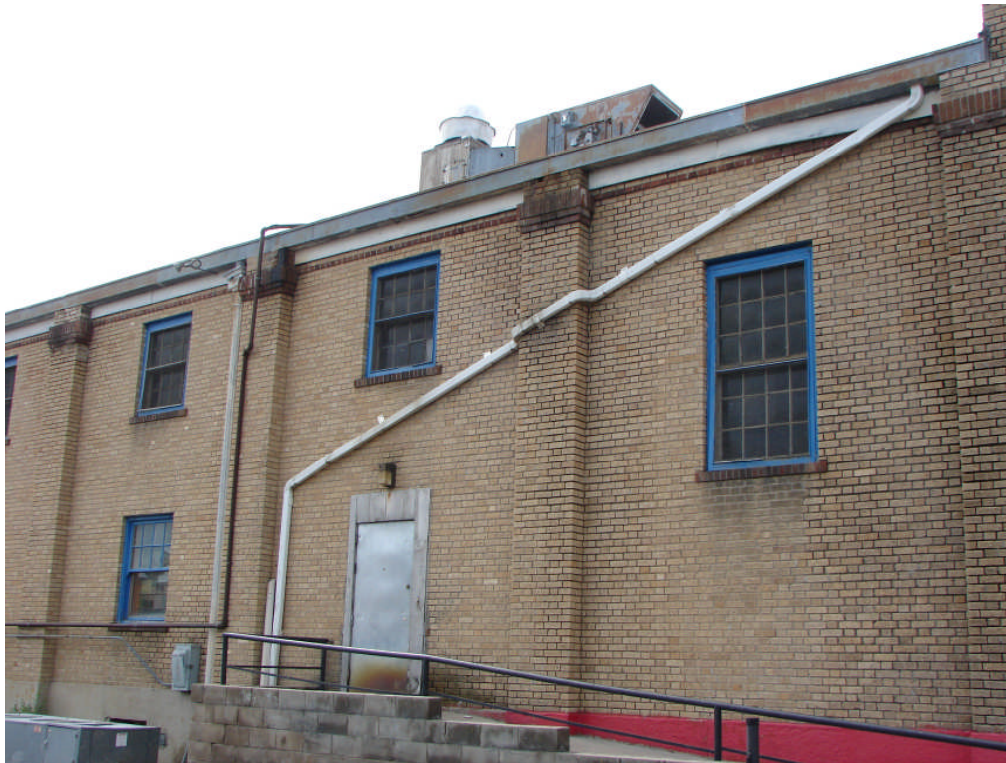
North façade downspouts and gutter system

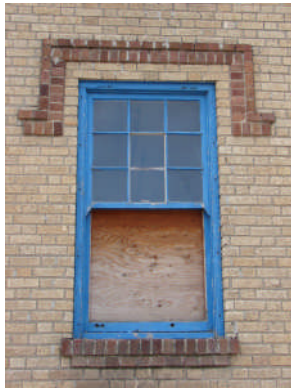
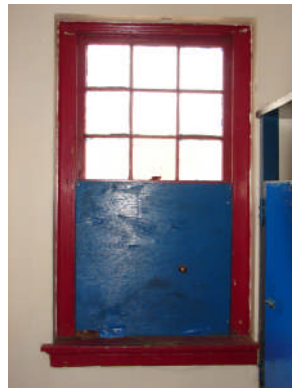
Window #5

Miscellaneous: Bottom sash of both windows has been covered up by plywood on the interior side, apparently for visual privacy. Divided lights are missing from bottom sash. Top sash missing one mullion

Recommendations: Remove the plywood panel. Restore lower sash. Replace all of the glass with obscure glass (if room remains a public toilet). Reconstruct missing mullion Remove all messy caulk joints. Repaint all frames and mullions white on both interior and exterior.~ restore window.

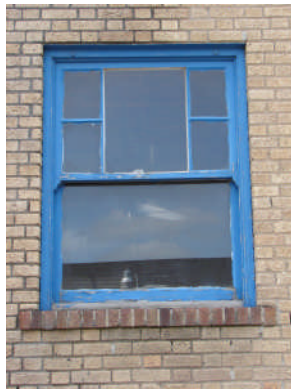
Window #6

Miscellaneous: From the original Huddart rendering p.12 it appears the intent was that this window had the same mullion spacing as the other windows. Because of the different size in all likelihood this one would have been 2x4 or 8 panels top and bottom sash for 16 total panels.

Recommendations: Reconstruct missing mullions similar to window #24. Remove all messy caulk joints. Repaint all frames and mullions white on both interior and exterior.. Make operable and Replace hardware~ restore window.

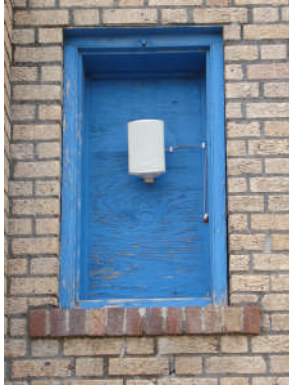
Window #7

Miscellaneous: This glass has been removed and replaced by plywood as there is currently a mechanical return air shaft located directly behind this opening. An exterior speaker is installed in the center of the opening apparently to provide music to the accessible ramp area.

Recommendations: Remove the speaker and wiring. Caulk and repaint all frames and plywood white. If the mechanical duct and shaft are relocated away from this opening, then we recommend complete restoration of this window and the reinstallation of glass.

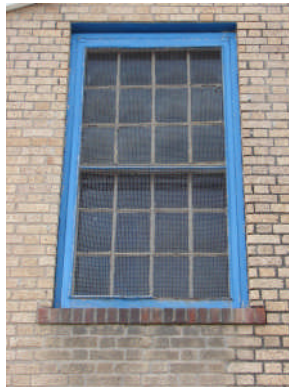
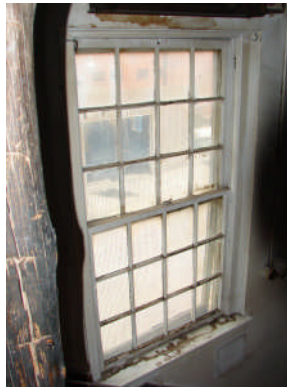
Window #8

Miscellaneous: This window has a fixed exterior screen with one center horizontal mullion aligning with the double hung window. Bottom screen frame stop is partially missing. Screen is in poor condition

Recommendations: Remove all messy caulk joints and paint from glass. Repaint all frames and mullions white on both interior and exterior.. Make operable and Replace hardware. Replace screen material with new and rebuild screen stops~ restore window.

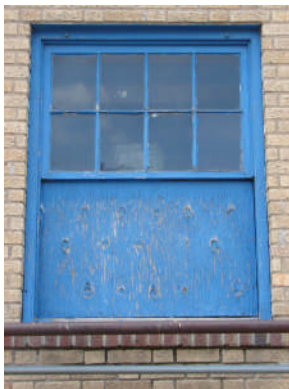
Window #10

Miscellaneous: Bottom sash has been in-filled with plywood as this window was located at an elevated platform used for booth seating

Recommendations: Open up wall to size of exterior rough opening. Remove the plywood panel and rebuild the bottom sash with true divided lights, (4x2 panels) Make operable and provide new hardware~ restore window. Remove all messy caulk joints and paint from glass. Prep, Caulk and repaint frame and mullions white on both interior and exterior..

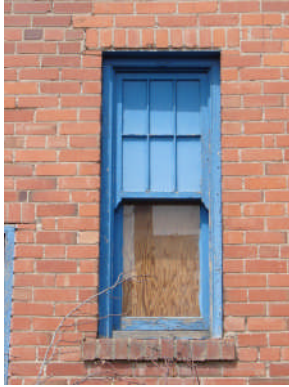
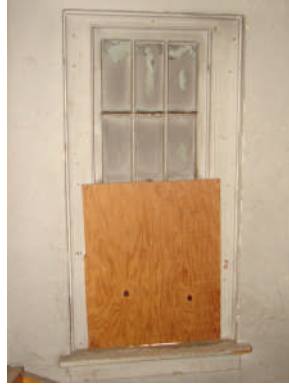
Window #14

Miscellaneous: There is a plywood infill at the bottom sash. Divided light mullions are missing

Recommendations: Re-build the bottom sash with divided light mullions (3x2). Re-glaze both top and bottom sash. Make operable and provide new hardware. Prep, Caulk and repaint frame and mullions white on both interior and exterior~ restore window.

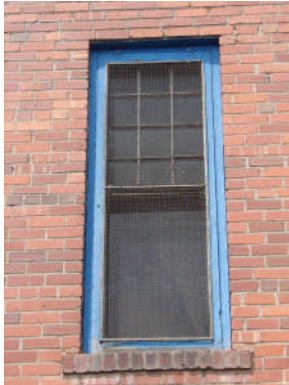
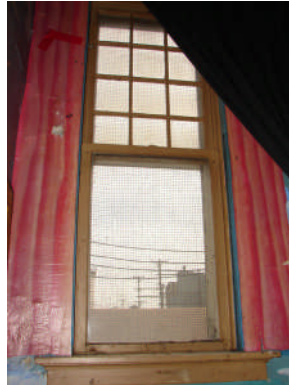
Window #15a

Hardware: catch lock, pull handle missing

Miscellaneous: Fixed exterior screen with one center horizontal mullion aligning with the double hung window. Screen is in poor condition. Divided light mullions are missing from the bottom sash.

Recommendations: Re-build and re-glaze the bottom sash with divided light mullions (3x4). Make operable and provide new hardware. Replace screen material with new and rebuild screen stops as necessary. Prep, Caulk and repaint frame and mullions white on both interior and exterior~ restore window.

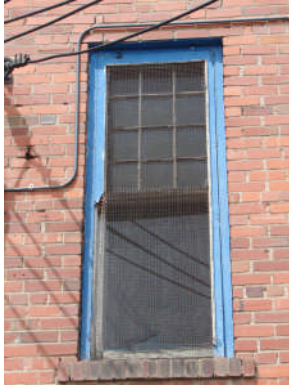
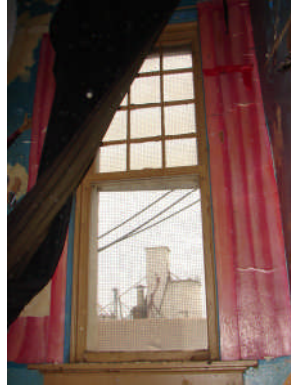
Window #15b

Hardware: catch lock, pull handle missing

Miscellaneous: Fixed exterior screen is in poor condition and is partially missing the screen wood stops. Divided light mullions are missing from the bottom sash.

Recommendations: Re-build and re-glaze the bottom sash with divided light mullions (3x4). Make operable and provide new hardware. Replace screen material with new and rebuild screen stops as necessary. Prep, Caulk and repaint frame and mullions white on both interior and exterior. ~ restore window.

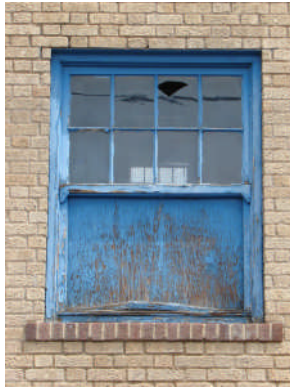
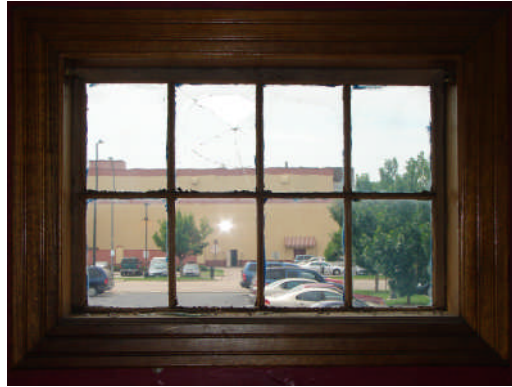
Window #18

Miscellaneous: Bottom sash has been in-filled with plywood as this window was located at an elevated platform used for booth seating. Bottom sash frame is broken. One pane of glass is broken in top sash

Recommendations: Open up wall to size of exterior rough opening. Remove the plywood panel and rebuild and re-glaze the bottom sash with true divided lights, (4x2 panels) Make operable and provide new hardware. Remove all messy caulk joints and paint from glass. Replace broken pane in top sash. Prep, Caulk and repaint frame and mullions white on both interior and exterior.~ restore window. Case the interior to match original profiles

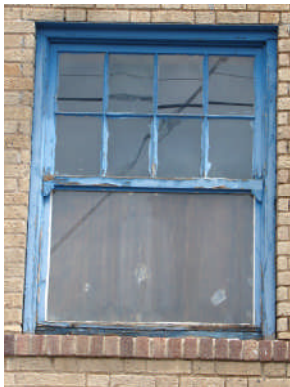
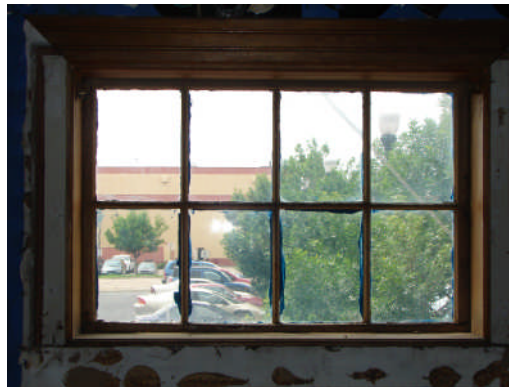
Window #19

Casing: wood picture framed (partially missing)

Miscellaneous: Bottom sash is in place but covered up on interior by millwork as this window was located at an elevated platform used for booth seating.

Recommendations: Open up wall to size of exterior rough opening. Re-build and re-glaze the bottom sash with true divided lights, (4x2 panels) Make operable and provide new hardware. Remove all messy caulk joints and paint from glass. Prep, Caulk and repaint frame and mullions white on both interior and exterior.~ restore window. Case the interior to match original profiles

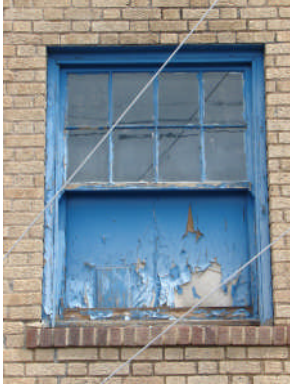
Window #20

Miscellaneous: This window is concealed and covered up on the interior by the Kitchen Pantry enclosure. Bottom sash has been in-filled with plywood and the divided light mullions are missing.

Recommendations: Remove interior pantry wall which is covering up this window. Make operable and Replace hardware. Re-build and re-glaze the bottom sash with true divided lights, (4x2 panels). Prep, Caulk and repaint frame and mullions white on both interior and exterior~ restore window.

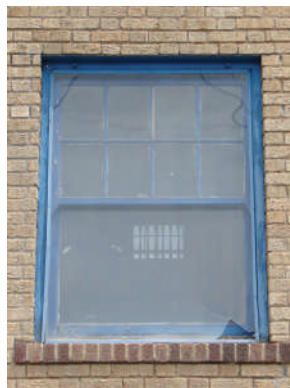
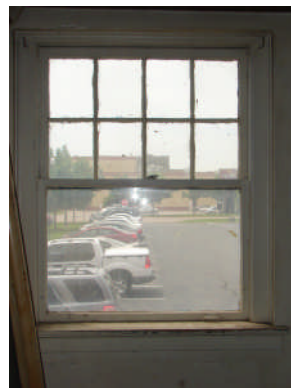
Window #21

Hardware: catch lock, one pull handle (left one missing)

Miscellaneous: Exterior screen has been replaced by plexiglass material which is broken. Bottom sash is missing the divided light mullions.

Recommendations: Remove outer plexiglass. Make operable and Replace hardware. Re-build and re-glaze the bottom sash with true divided lights, (4x2 panels). Prep, Caulk and repaint frame and mullions white on both interior and exterior~ restore window.

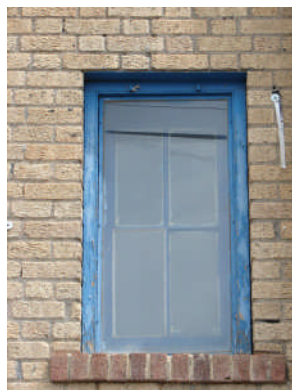
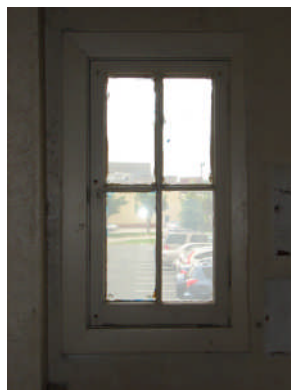
Window #23

Hardware: missing

Miscellaneous: The screen material on the exterior has been replaced by plexiglass

Recommendations: Remove plexiglass and replace with screen material. Make operable and Replace hardware. Remove all messy caulk joints and paint from glass. Prep, Caulk and repaint frame and mullions white on both interior and exterior~ restore window.

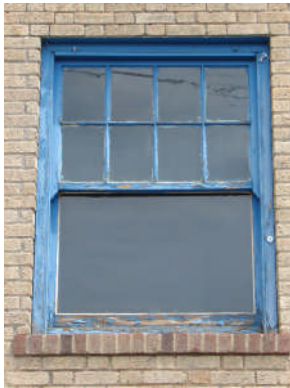
Window #24

Hardware: center catch lock, 1 pull handle (right missing)

Miscellaneous: Bottom sash is missing the divided light mullions

Recommendations: Make operable and Replace hardware. Re-build and re-glaze the bottom sash with true divided lights, (4x2 panels). Prep, Caulk and repaint frame and mullions white on both interior and exterior~ restore window.

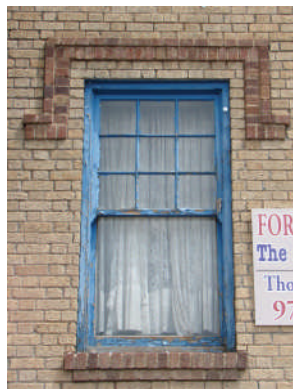
Window #25

Miscellaneous: This window is located in a bathroom and visual privacy is provided by curtains only. Divided lights are missing from bottom sash. Top sash missing one mullion

Recommendations: Make operable and Replace hardware. Re-build and re-glaze the bottom sash with true divided lights, (3x3 panels). Replace all of the glass with obscure glass (if room remains a public toilet). Prep, Caulk and repaint frame and mullions white on both interior and exterior~ restore window.

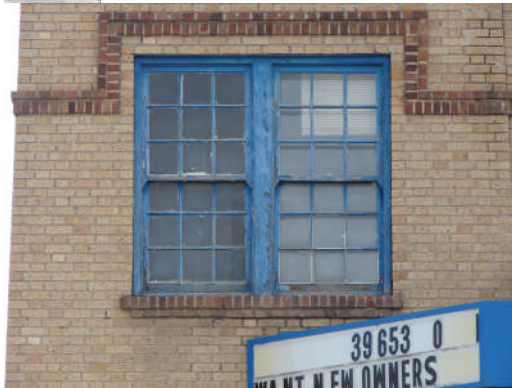
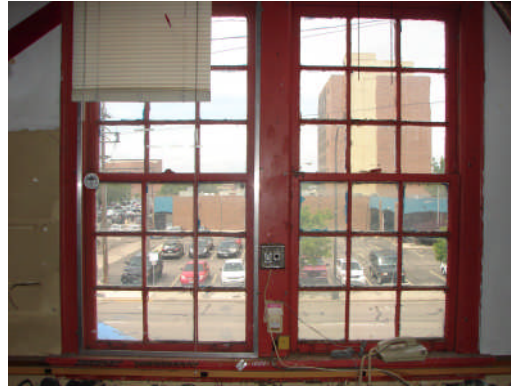
Windows #31 and 32

Miscellaneous: Electrical wire mold raceway mounted on the face of the interior wood sill stool. Telephone jack boxes surface mounted to the center mullion. Window 31 has partial blind mounted to the head casing and an aluminum framed storm type window mounted on the interior side.

Recommendations: Remove blind and storm panel from window 31. Remove telephone jack boxes and electrical wire mold raceway. Make operable and provide new hardware. Remove all messy caulk joints and paint from glass. Prep, Caulk and repaint frame and mullions white on both interior and exterior~ restore. Reconstruct new screen and stops to match originals.

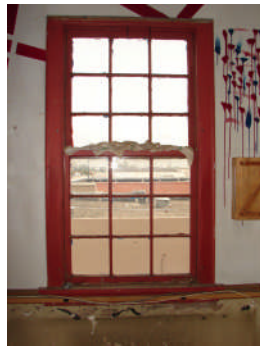
Window #33

Miscellaneous: Apparently this window leaked bad enough that someone felt that stuffing a towel between the top and bottom sash would be a good idea to stop air infiltration. Electrical wire mold raceway mounted on the face of the interior wood sill stool.

Recommendations: Remove electrical raceway wire mold. Removal towel. Make operable and provide new hardware. Remove all messy caulk joints and paint from glass. Prep, Caulk and repaint frame and mullions white on both interior and exterior~ restore window. Reconstruct new screen and stops to match originals.

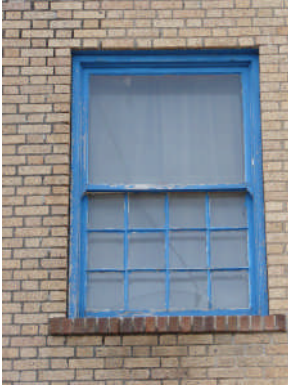
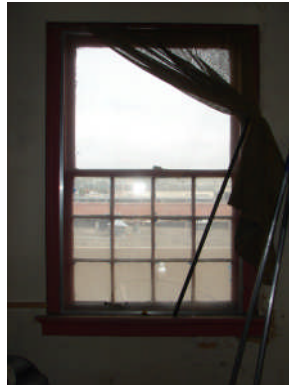
Window #34

Miscellaneous: The top sash is missing the divided light mullions. There is an aluminum frame storm window with broken glass mounted on the Interior side. There is also a curtain and rod surface mounted on the head casing.

Recommendations: Remove aluminum storm and curtain rod. Make operable and provide new hardware. Re-glaze top sash and provide mullions. Remove all messy caulk joints and paint from glass. Prep, Caulk and repaint frame and mullions white on both interior and exterior.~ restore window. Reconstruct new screen and stops to match originals.

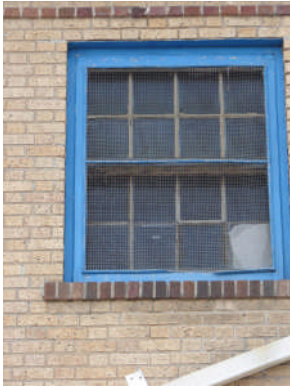
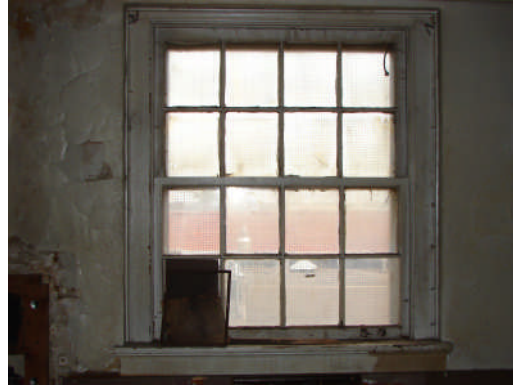
Window #36

Miscellaneous: This window has a fixed exterior screen with one center horizontal mullion aligning with the double hung window. Bottom screen frame stop is partially missing. Screen is in poor condition

Recommendations: Make operable and provide new hardware. Remove all messy caulk joints and paint from glass. Prep, Caulk and repaint frame and mullions white on both interior and exterior~ restore window. Replace screen material with new and rebuild screen stops.

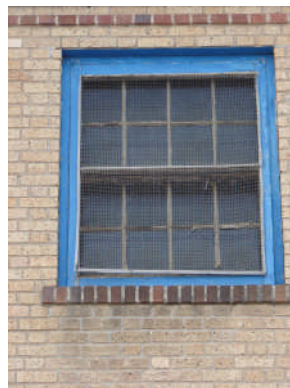
Window #37

Miscellaneous: This window has a fixed exterior screen with one center horizontal mullion aligning with the double hung window. The screen frame stops are warped and out of plane. Screen is in poor condition

Recommendations: Make operable and provide new hardware. Remove all messy caulk joints and paint from glass. Prep, Caulk and repaint frame and mullions white on both interior and exterior~ restore window. Replace screen material with new and rebuild screen stops.

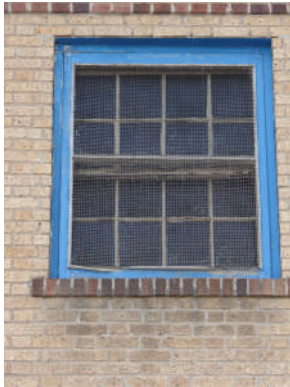
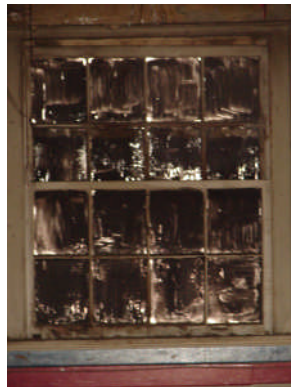
Window #38

Miscellaneous: This window has a fixed exterior screen with one center horizontal mullion aligning with the double hung window. Bottom screen frame stop is partially missing. Screen is in poor condition. Interior side of the windows has been painted black

Recommendations: Make operable and provide new hardware. Remove all messy caulk joints and paint from glass. Prep, Caulk and repaint frame and mullions white on both interior and exterior~ restore window. Replace screen material with new and rebuild screen stops.
