G R E E L E Y A R M O R Y
6 1 4 8 t h A v e n u e
G r e e l e y , C o l o r a d o 8 0 6 3 1

HISTORIC
STRUCTURE
ASSESSMENT
2009-HA-022

1 0 . 1 . 2 0 0 9

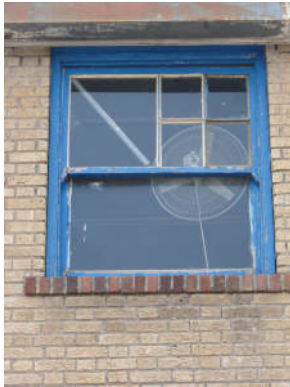
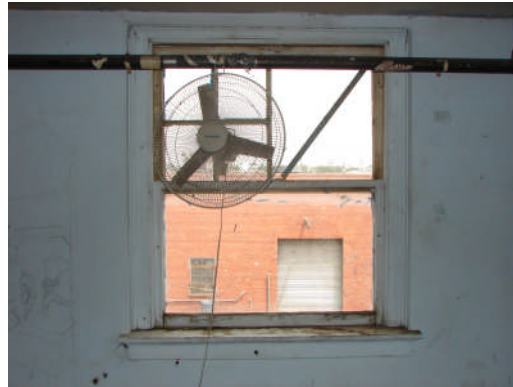
Window #40

Miscellaneous: Bottom sash is missing the divided light mullions and top sash is also missing some of the mullions. Top sash is misaligned and sagging.

Recommendations: Re-glaze bottom and top sashes and provide mullions. Make operable and provide new hardware. Remove all messy caulk joints and paint from glass. Prep, Caulk and repaint frame and mullions white on both interior and exterior. ~ restore window. Reconstruct new screen and stops to match originals.

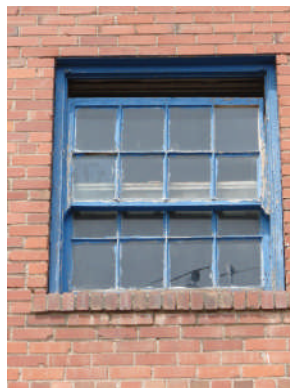
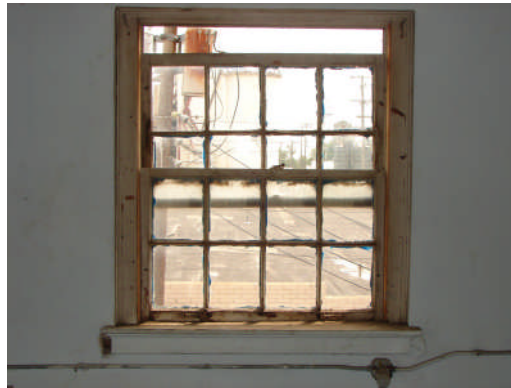
Window #41

Miscellaneous: Top sash is misaligned and sagging and not fully closed/engaged at the head

Recommendations: Reset top sash. Make operable and provide new hardware. Remove all messy caulk joints and paint from glass. Prep, Caulk and repaint frame and mullions white on both interior and exterior. ~ restore window. Reconstruct new screen and stops to match originals.

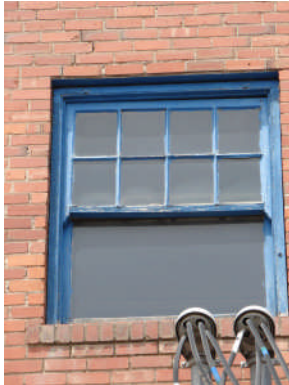
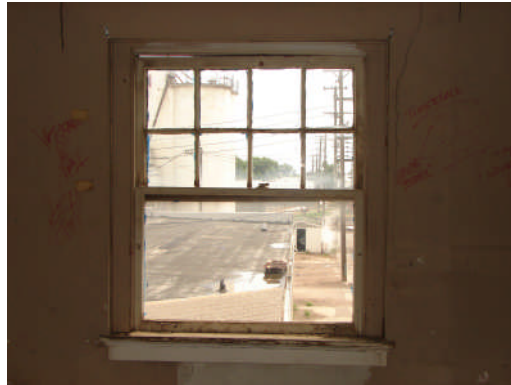
Window #42

Miscellaneous: Top sash is misaligned and sagging. Bottom sash missing mullions.

Recommendations: Reset top sash. Re-glaze bottom sash and provide mullions. Make operable and provide new hardware. Remove all messy caulk joints and paint from glass. Prep, Caulk and repaint frame and mullions white on both interior and exterior. ~ restore window. Reconstruct new screen and stops to match originals.

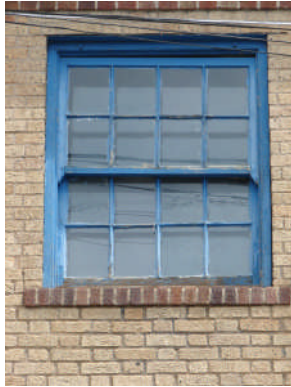
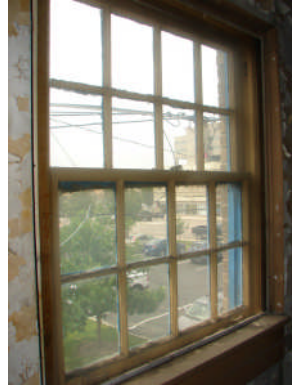
Window #44

Miscellaneous: There is an aluminum frame storm window mounted on the interior side. Top sash is misaligned and sagging.

Recommendations: Remove interior storm panel. Reset top sash. Make operable and provide new hardware. Remove all messy caulk joints and paint from glass. Prep, Caulk and repaint frame and mullions white on both interior and exterior. ~ restore window. Reconstruct new screen and stops to match originals.

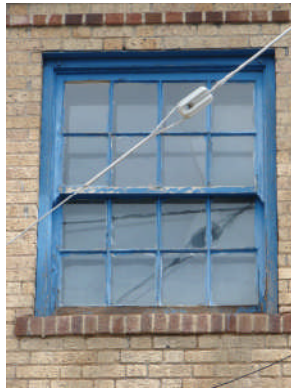
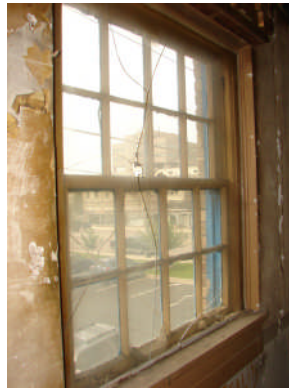
Window #45

Miscellaneous: There is an aluminum frame storm window mounted on the interior side. Storm glass is broken. Top sash is misaligned and sagging.

Recommendations: Remove interior storm panel. Reset top sash. Make operable and provide new hardware. Remove all messy caulk joints and paint from glass. Prep, Caulk and repaint frame and mullions white on both interior and exterior. ~ restore window. Reconstruct new screen and stops to match originals.

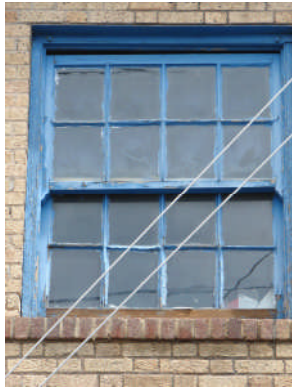
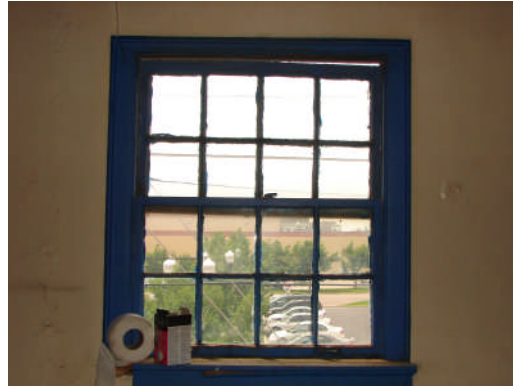
Window #46

Miscellaneous: Top sash is misaligned and sagging. Interior sill and stool is partially missing at left jamb

Recommendations: Reset top sash. Make operable and provide new hardware. Remove all messy caulk joints and paint from glass. Prep, Caulk and repaint frame and mullions white on both interior and exterior.~ restore window. Reconstruct new screen and stops to match originals.

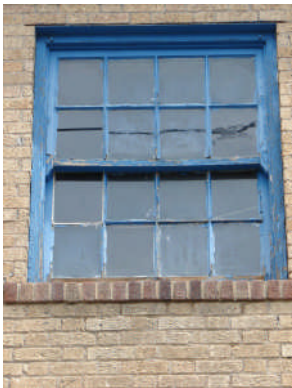
Window #47

Miscellaneous: Window head, sill, jambs and mullions have been painted multiple colors.

Recommendations: Make operable and provide new hardware. Remove all messy caulk joints and paint from glass. Prep, Caulk and repaint frame and mullions white on both interior and exterior.~ restore window. Reconstruct new screen and stops to match originals.

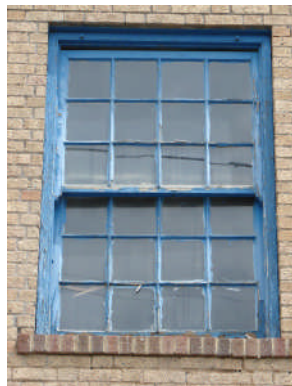
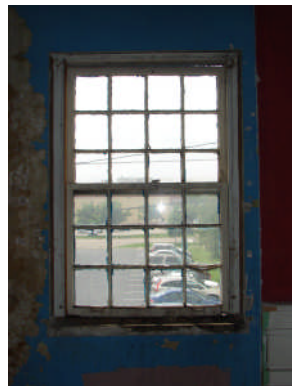
Window #49

Casing: wood, wood sill missing

Miscellaneous: the interior wood sill is missing. Top sash is misaligned and sagging. One of the bottom sash mullions is broken

Recommendations: Reset top sash. Repair bottom sash mullion. Make operable and provide new hardware. Remove all messy caulk joints and paint from glass. Prep, Caulk and repaint frame and mullions white on both interior and exterior.~ restore window. Reconstruct new screen and stops to match originals.

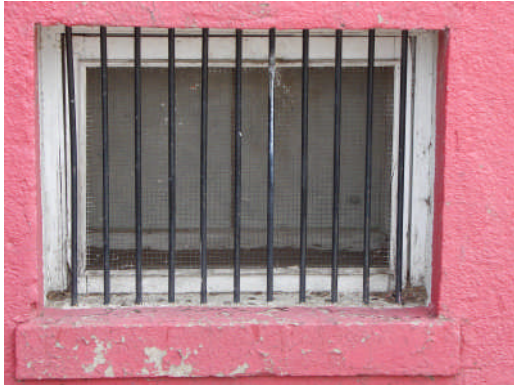
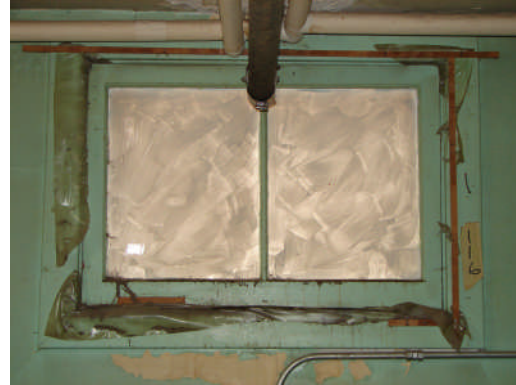
Window #51

Miscellaneous: Exterior has fixed vertical security bars. Far left bar bent. Window is screened implying at one point this window was operable. There is dirt trapped and piled between the screen and the frame.

Recommendations: Remove paint from glass or re-glaze. Remove trapped dirt. Prep, caulk and re-paint frame white. Repaint bars black

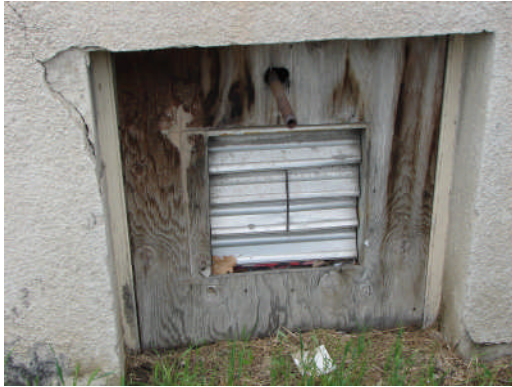
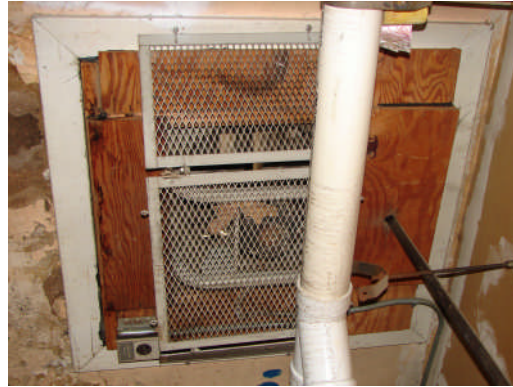
Window #57

Miscellaneous: This window has been converted to a mechanical louver. The louver is smaller than the overall opening so it is centered in a plywood panel. A condensate pipe penetrates the plywood panel centered above the louver. The sill is flush with grade.

Recommendations: Re-grade to slope away from sill and remove vegetation. Provide flashing at sill so moisture will not migrate into this opening. Prep, caulk and re-paint frame and plywood panel white. If mechanical is removed then restore original window.

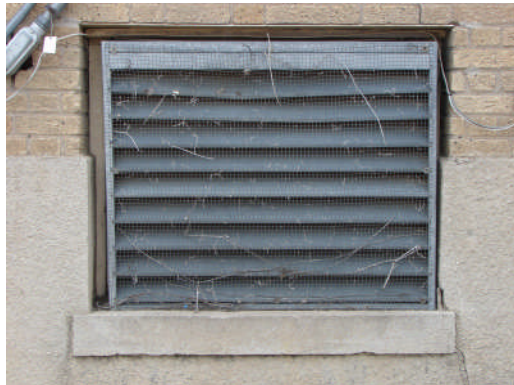
Window #60

Miscellaneous: This window has been converted to a mechanical fresh air intake louver for Air Handler No.2. A bird screen material has been added to the exterior of the louver as well.

Recommendations: Caulk and seal all joints around frame

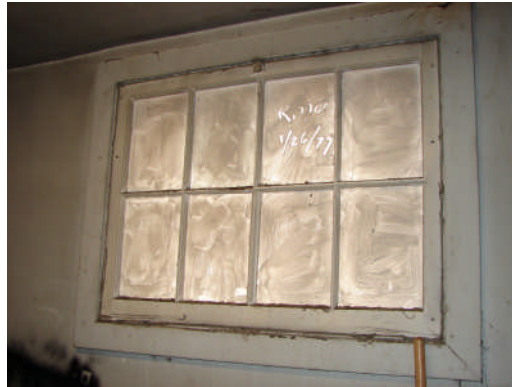
Window #63

Miscellaneous: Exterior has fixed vertical security bars. Window is screened implying at one point this window was operable.

Recommendations: Remove paint from glass or re-glaze. Prep, caulk and re-paint frame white. Repaint bars black

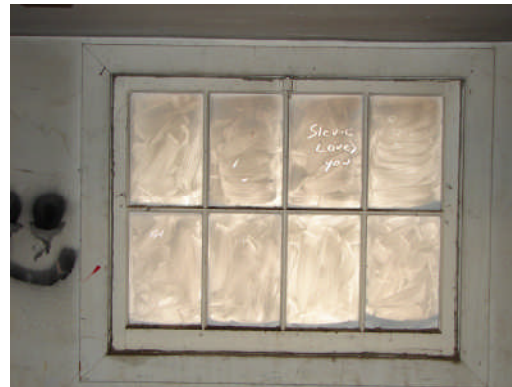
Window #64

Miscellaneous: Exterior has fixed vertical security bars which have been over painted. Window is screened implying at one point this window was operable. Window screen is warped and out of plane and open in the bottom left corner

Recommendations: Remove paint from glass or re-glaze. Replace screen material and repair screen stops. Prep, caulk and re-paint frame white. Repaint bars black

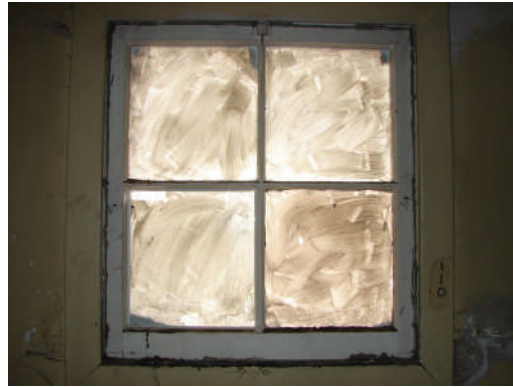
Window #65

Miscellaneous: Exterior has fixed vertical security bars ~ center bar is bent and distorted. Dirt has piled up behind the security bars and completely covers the bottom frame and sill. Bottom right pane broken.

Recommendations: Remove trapped dirt. Re-glaze. Prep, caulk and re-paint frame white. Repaint security bars black

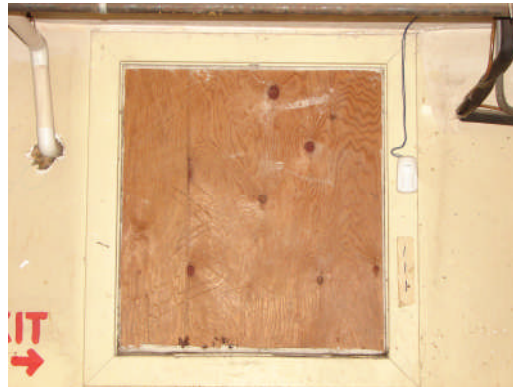
Window #66

Miscellaneous: Glass has been removed and replaced by plywood. Exterior has fixed vertical security bars which have been over painted. Dirt has piled up behind the security bars and completely covers the bottom frame and sill. Window is screened implying at one point this window was operable.

Recommendations: Remove trapped dirt. Re-glaze with 4 panes similar to window #65. Prep, caulk and re-paint frame white. Repaint security bars black

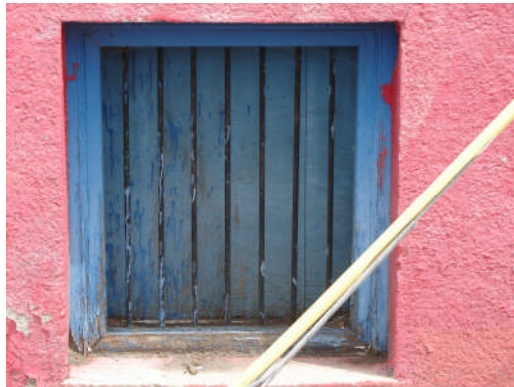
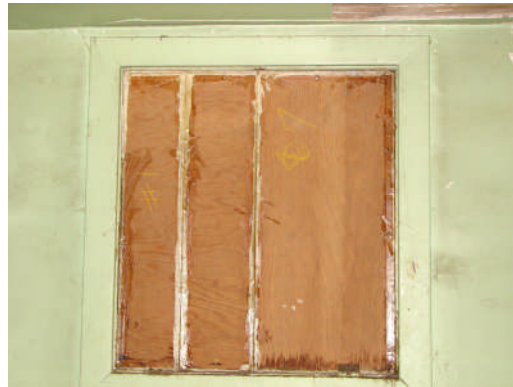
Window #67

Miscellaneous: Glass has been removed and replaced by plywood. Exterior has fixed vertical security bars which have been over painted.

Recommendations: Re-glaze with 4 panes similar to window #65. Prep, caulk and re-paint frame white. Repaint security bars black

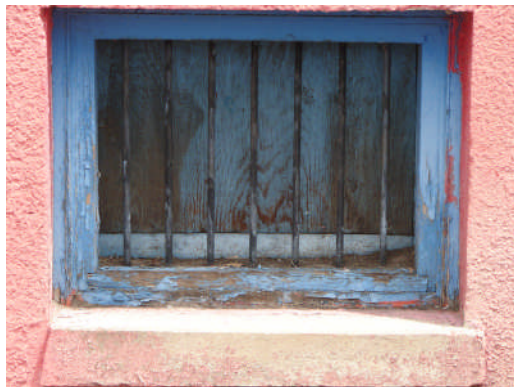
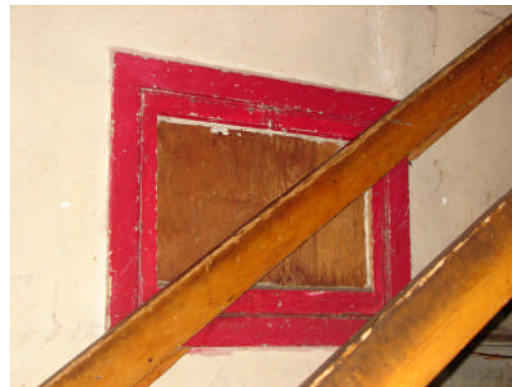
Window #68

Miscellaneous: Glass has been removed and replaced by plywood. Exterior has fixed vertical security bars which have been over painted.

Recommendations: Re-glaze with 2 panes similar to window #55. Prep, caulk and re-paint frame white. Repaint security bars black

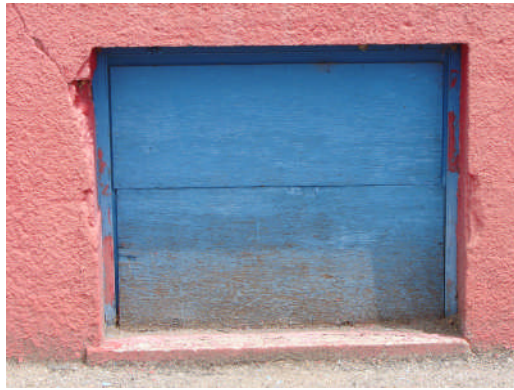
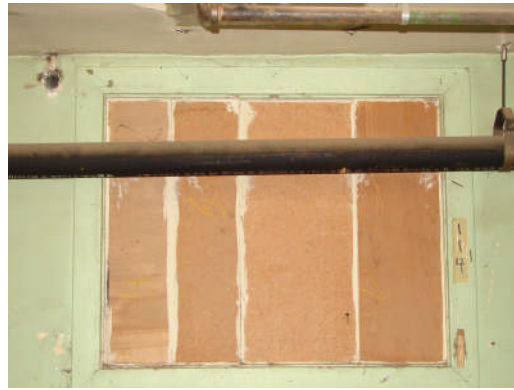
Window #69

Miscellaneous: Glass has been removed and replaced by plywood.

Recommendations: Re-glaze with divided light mullions 2 high x 4 wide similar to window #63. Prep, caulk and re-paint frame white.

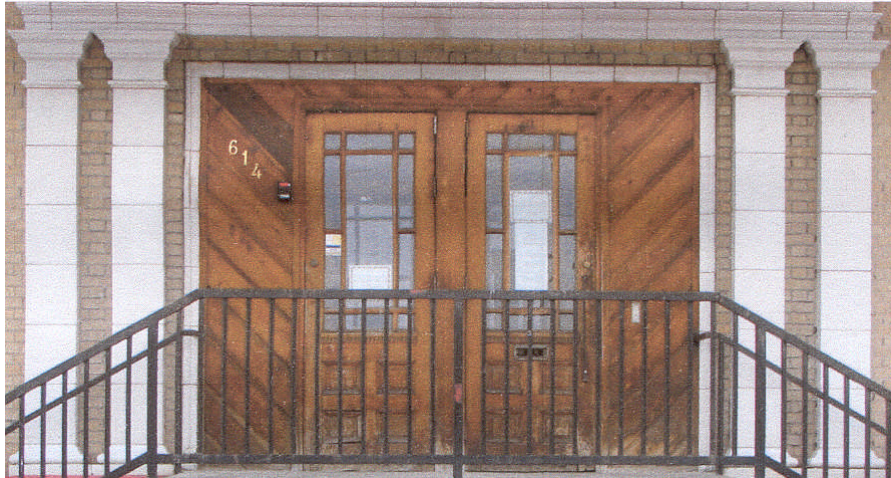
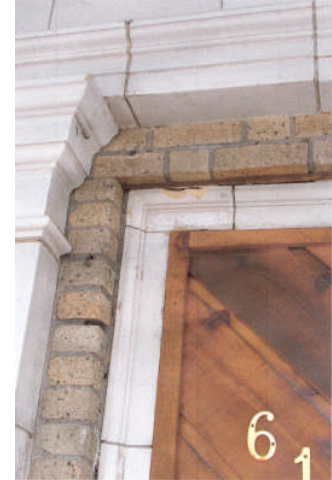
All of the original interior and exterior doors have been removed and replaced (except for the loading dock door) as a part of the dramatic interior transformation that took place in 1978 when the building was converted into a restaurant. As such our assessment on doors is limited to a discussion about reconstruction of the Main Entry doors off of 8th Avenue and the Alley loading dock.

Current Main Entry door way ca.1978 with terra cotta door surround ca.1922

Recommendations: Remove doors and side wood panels in their entirety (to the limits of the terra cotta surround which is original). Reconstruct new doors according to historical documentation with square divided light patterns (3wide x 5 high) each door as well as the side panels. Doors to swing out with hinges on opposing jambs with no center post. Location of doors to be recessed as it was originally. Provide code required egress hardware. Paint all doors and trim and side panels white.

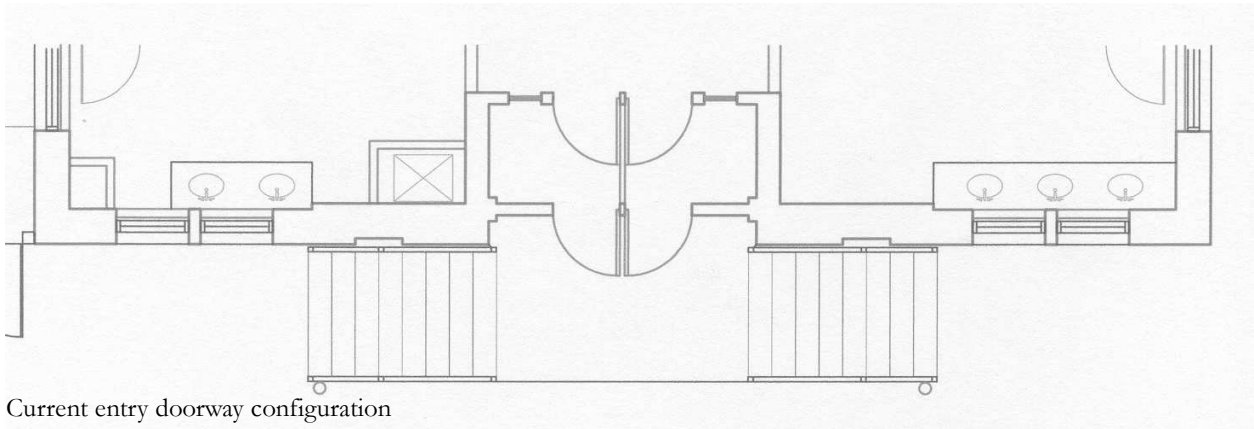
Current entry doorway configuration

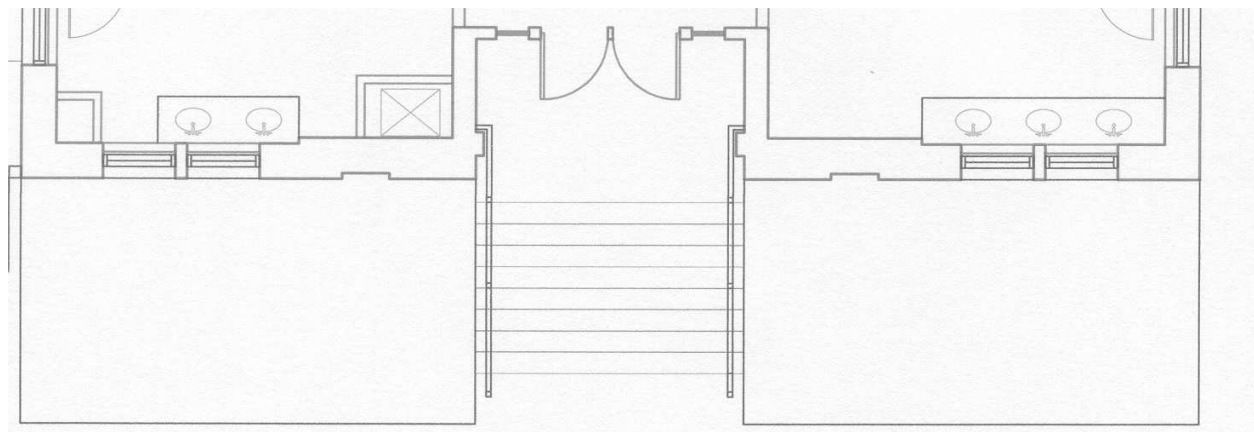
Proposed entry doorway re-configuration

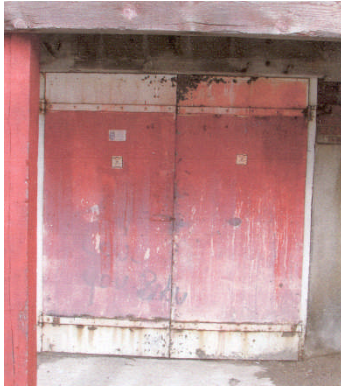
East Alley loading dock door

Miscellaneous: These doors are original. They are located beneath the level one elevated loading dock and provide direct access into the basement level. They are in functioning order at this time although the locking mechanism is a steel bar and therefore not operable from the exterior.. Painted red in color.

Recommendations: Prep, caulk and paint doors and frames white. Provide keyed deadbolt hardware and simple steel pulls on both doors.

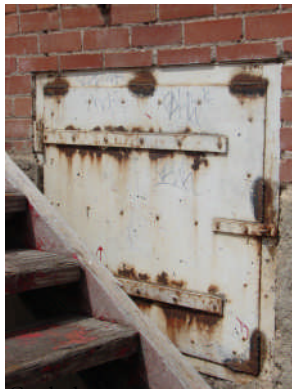
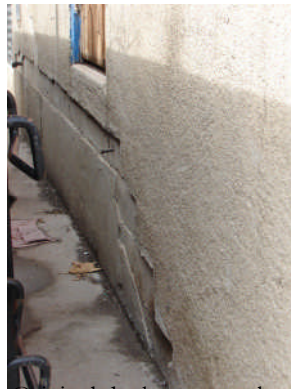
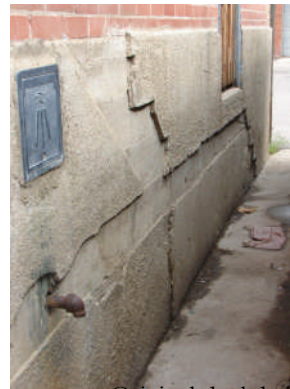
Coal Chute door

Coal chute

Original dock

location

Original dock height

Miscellaneous: This is the original coal chute door. The coal room used to be what now is the Electrical Room in the basement. It was located at the original loading dock height. That dock has been removed but the memory of it is etched into the structure forever.

Recommendations: Prep, caulk and paint door and frame white. Leave welded shut.

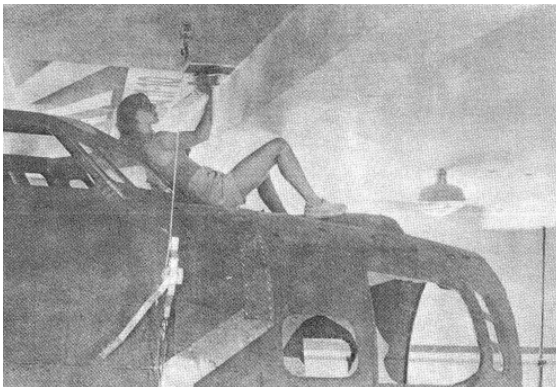
There are plaster drops at each grid line to conceal the bottoms of the trusses. This is due to the ceiling joists being framed over the top of the truss bottom cords. Although these locations are currently concealed by other added ceiling elements from 1978, a historic photo clearly shows these plaster drops.

Ceiling work ca. 1978 restaurant modifications at grid G truss/drop beam

- Remove all wallpaper, added drop trim pieces and other miscellaneous components that were added below or on the plaster.
- Patch and repair all ceiling plaster finishes per the National Park Service Preservation Brief No. 21 guidelines.

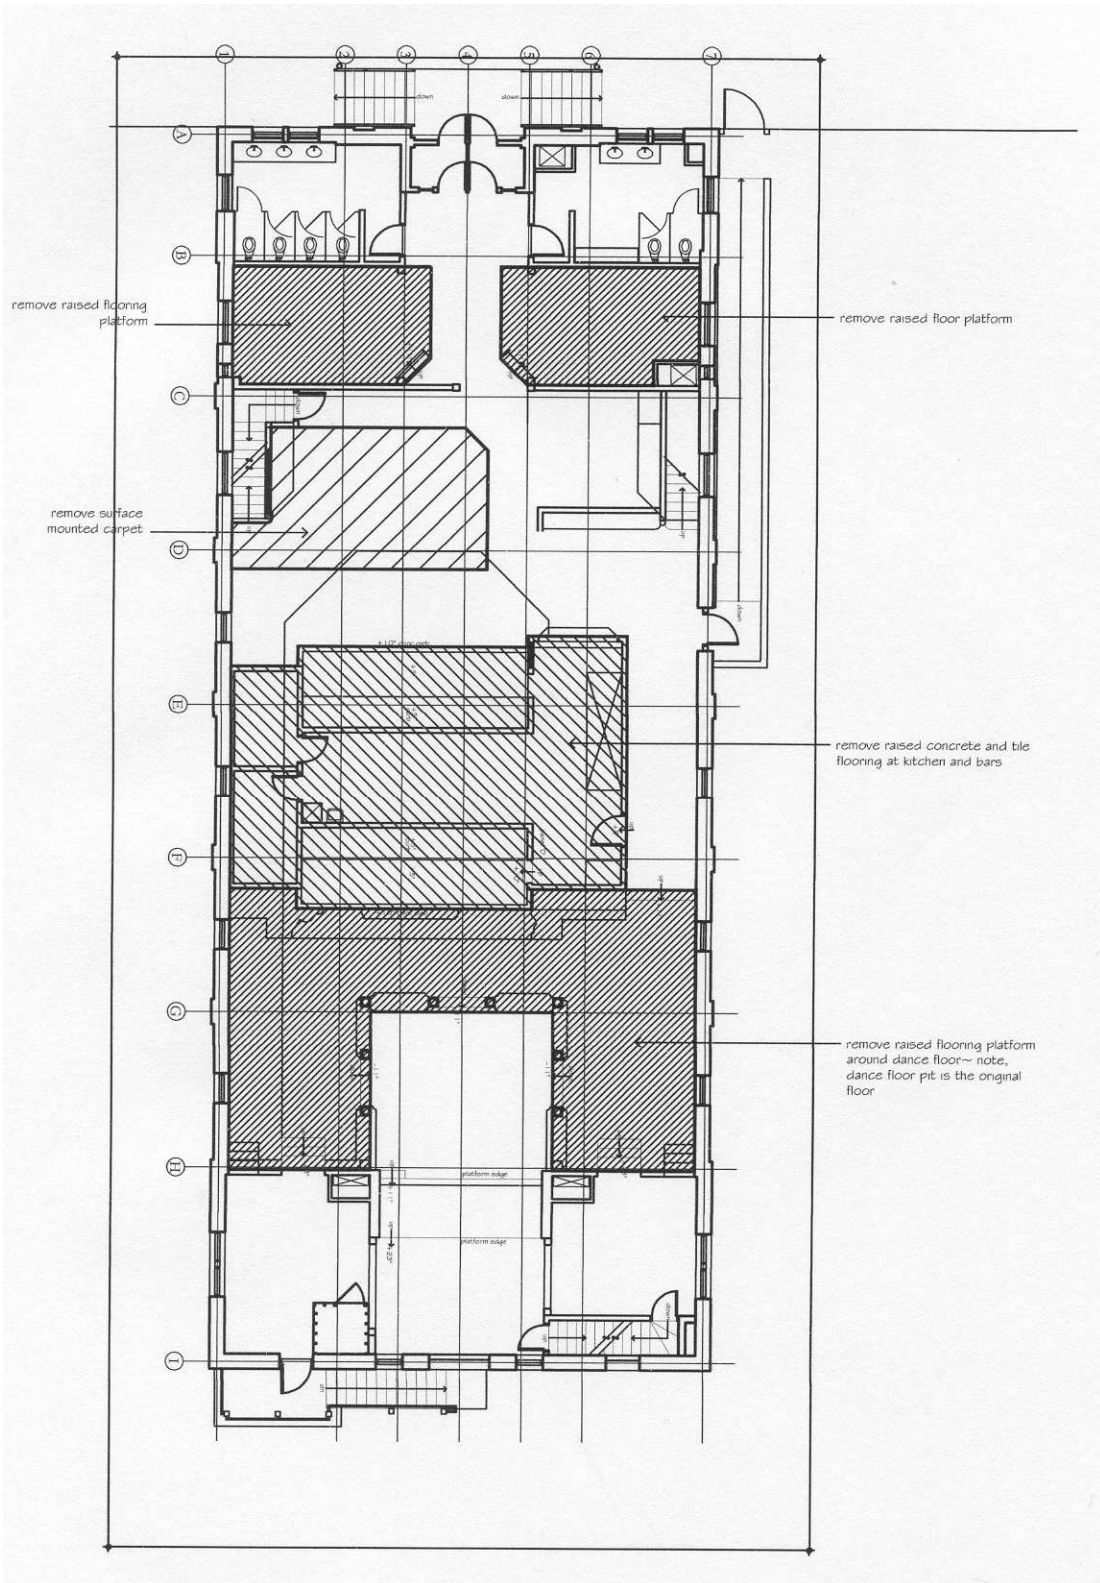
An elevated floor deck was over framed over this historic wood floor in 1978 around the back bar dance floor area and as such is ca.1978 vintage in 5" plank widths. The newer flooring on the elevated portions is of much lower quality and is in much worse condition than the original maple below.

Diagram of Level One areas where original flooring is covered up

- Elevated floor decks over original floors should be removed to expose the original flooring below. This includes the back bar area~980 SF, The (2) front platforms by the bathrooms~ 440 SF and the raised kitchen tiled area~ 1,012 SF
- Remove carpeted area at the front bar area~ 328 SF
- Original flooring throughout should be repaired and patched as needed using woven patches to preserve the original appearance of the floors.
- Once repaired, the original floors should be sanded to remove all old finishes, sealed with an oil based sealer coat to maintain the developed color of the flooring, and refinished using a high quality commercial grade polyurethane to provide long wearing surface protection.

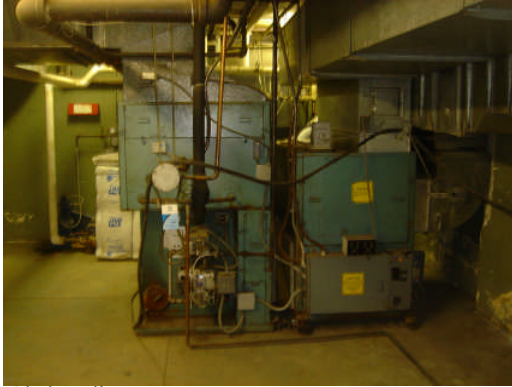
Air handler No.1

- Manufacturer: Tjernlund
- 1978 model # BF500THC-50
- 15 ton capacity
- 15 hp compressor
- Rated at 250,000 BTU/Hr
- Fresh air intake is ducted from louvers set into 2 north basement windows and is controlled by an economizer/damper.
- Combustion air is ducted in from a West basement window right at the water service entrance
- Condenser for this unit is a 1978 T.S.I.(Technical Systems, Inc.) model and is located on grade at grid 7E. Power disconnect is located on the wall immediately behind the unit.

McCreery & Sun has provided maintenance on both furnaces since 1982. In 2002 they rebuilt Air Handler No.2. Even given that major overhaul, they believe the units have reached the end of their life cycle and recommend that they both be replaced at this time.

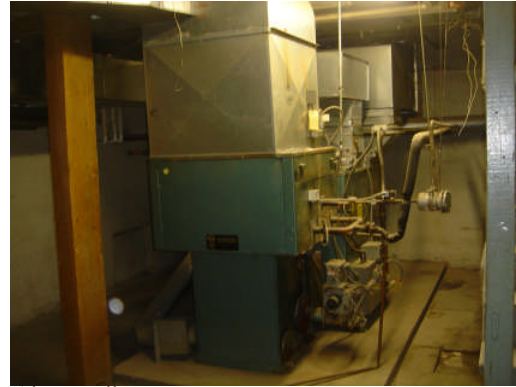
Air Handler No.2

- 10 hp compressor
- Rated at 187,500 BTU/Hr
- Fresh air intake is ducted from a louver set into 1 north basement window and is controlled by an economizer/damper.
- Combustion air is ducted in from a East basement window
- A fire smoke damper has been opened in the main distribution duct to get some nominal heat into this room
- Condenser is a 1978 T.S.I.(Technical Systems, Inc.) model is located on grade at grid 7G

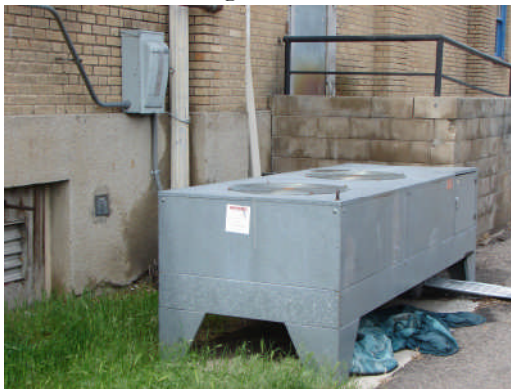
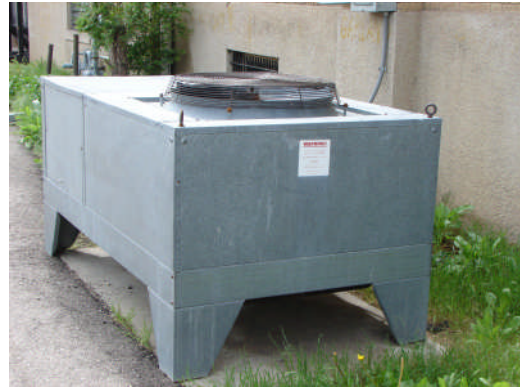
Condenser for Air Handler No.1

Condenser for Air Handler No.2

- Condenser locations currently at grid E and G will need to be set on grade further to the East about grid line H and I. Electrical disconnects on the exterior wall will also need to be relocated accordingly.
- Provide a wall mounted handrail and a metal guardrail on the open side
- Space under the ramp should be left open along the outer edges so debris can easily be removed by rake.
- Infill existing door at grid 7D and return it to a window opening similar to the original. Use the removed window from new door location (as noted below).
- Remove window at grid 7F and open up wall for new door. Salvage window for reinstallation at current door location to be in-filled (as noted above).

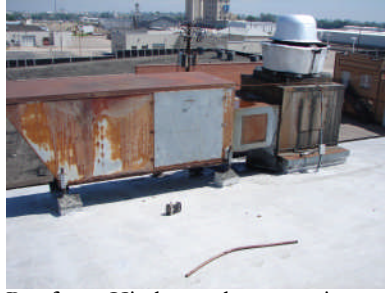
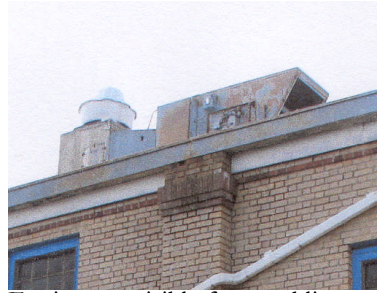
Roof top Kitchen exhaust equipment

Equipment visible from public way

- Verify functionality of bathroom ventilation fans, replace with new if necessary and conceal the ventilation ducts in small shafts or walls to be integrated into any future work
- Remove Kitchen exhaust hood, fan and all roof top mounted equipment. If another Kitchen function occurs in the future new use, then all new code complying equipment should be installed. Avoid placing any equipment on the vaulted portion of the roof.

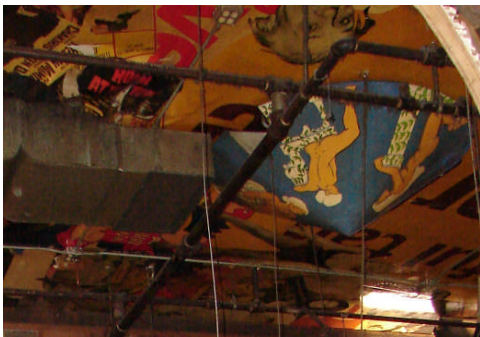
Fire valve is not sealing correctly and when under pressure is allowing water to leak out into the system distribution pipes.

The last inspection by Union Colony Fire Rescue Authority noted that the valve should be replaced and the sprinkler heads cleaned or replaced.

Typical suspended fire protection piping and heads

- Provide new dedicated fire system tap and entrance piping.
- Replace the Fire valve at the entrance
- Provide a source of heat at the fire valve entrance as the current Air Handler No.1 combustion air is putting cold air right on the valve, and or move combustion air intake~ concerns of freezing during the winter months should be addressed in some manner.

- Replace all sprinkler heads with new devices and install to be sensitive to the historic character of the building. Drops will need to be modified in length depending on reuse and ceiling heights. I.e. If the Kitchen is eliminated and the main volume of space restored then there will be major changes necessary to the sprinkler protection layout.
